**Sample Report  
1234 Sample Report  
Fulshear, TX 77441**

**December 19, 2025**

## PROPERTY CONDITION REPORT

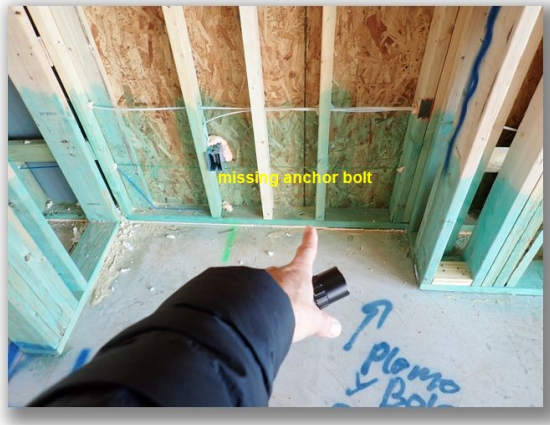
- There are not enough anchor bolts or straps in place in the living room. Under current code requirements, bottom plates shall be anchored to the foundation with anchor bolts or strap spaced a maximum of 6 feet on center. There should be a minimum of two bolts or straps per plate section with one bolt or strap located not more than 12 inches or less than seven bolt diameters from each end of the plate section.

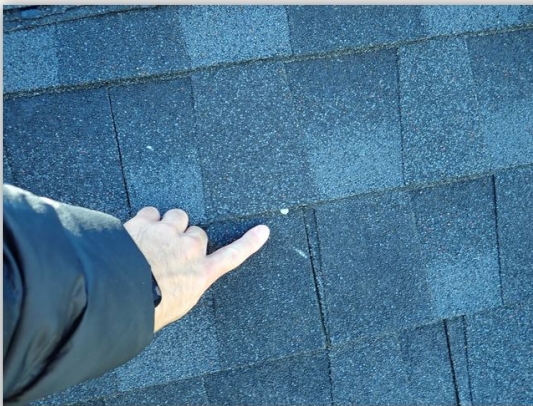
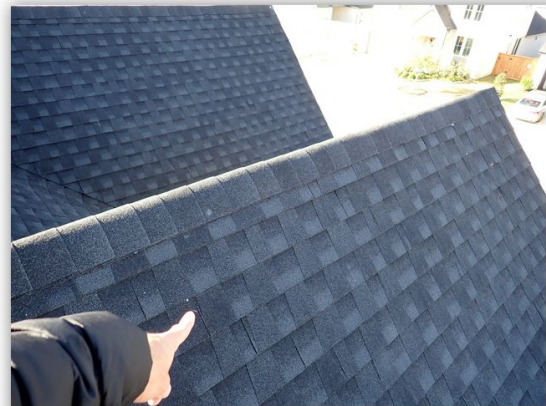
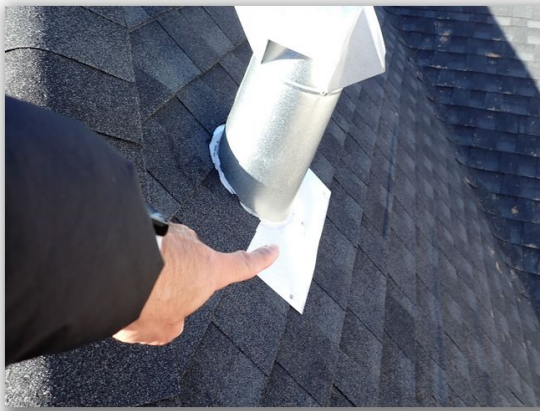
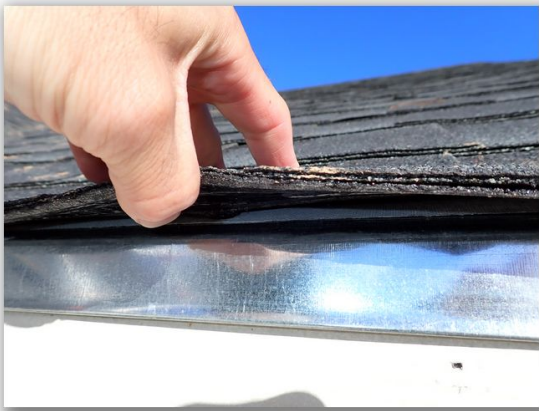
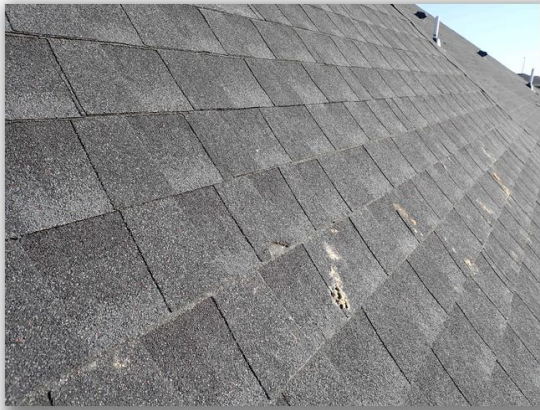
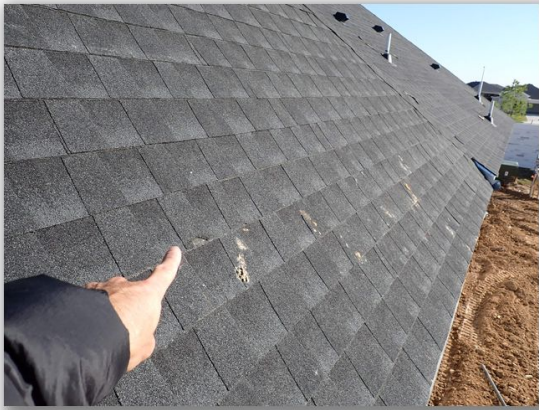
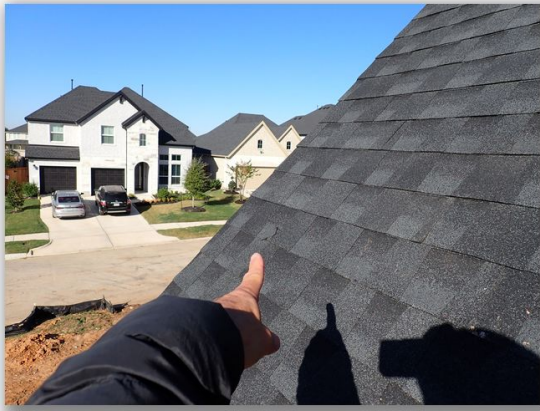
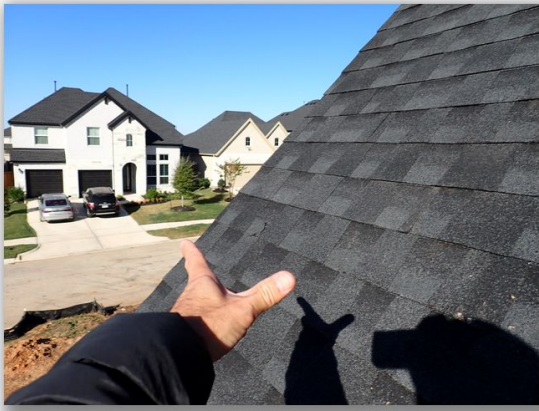
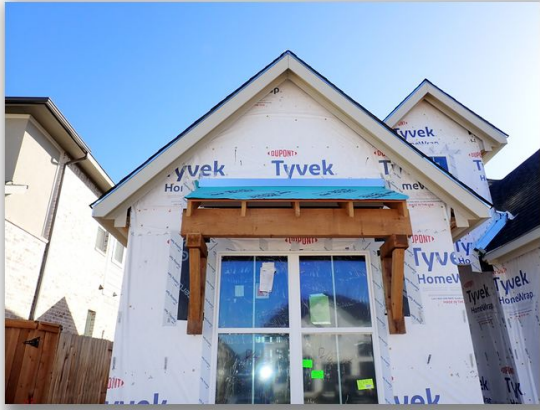
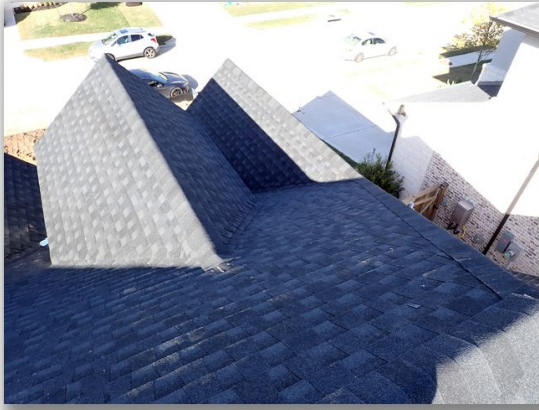
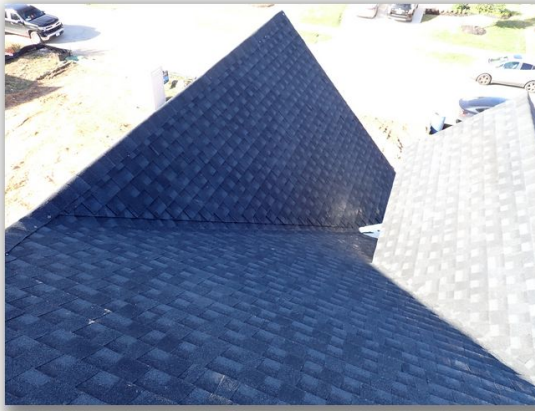
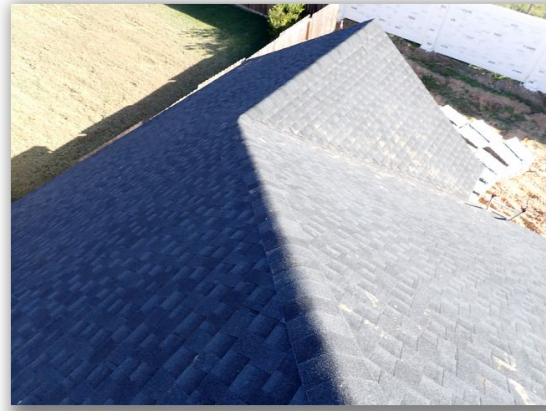
- Exposed fasteners were observed at the shingles in one or more locations.
- Damaged shingles were observed on the south side of the roof structure.
- The metal roof was observed to be unfinished at the time of inspection.

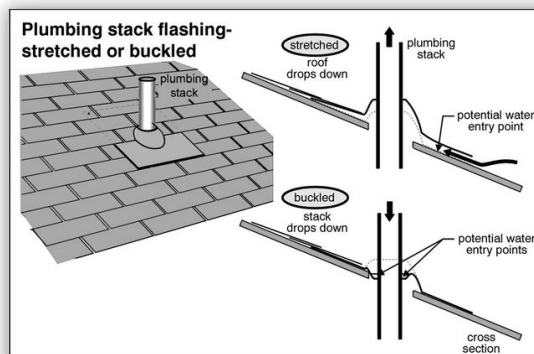
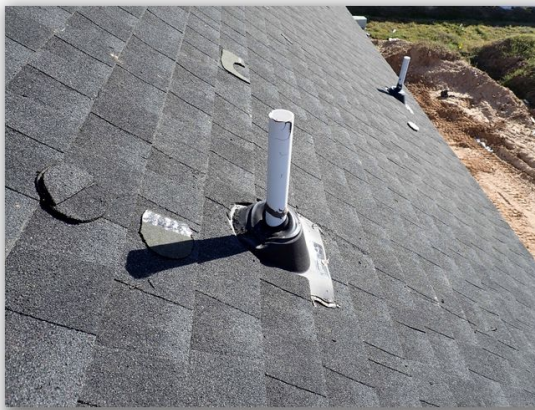
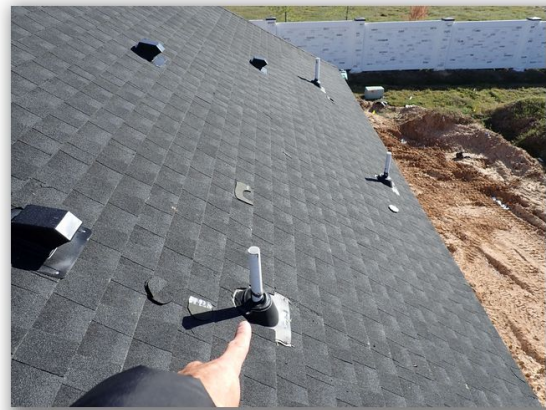
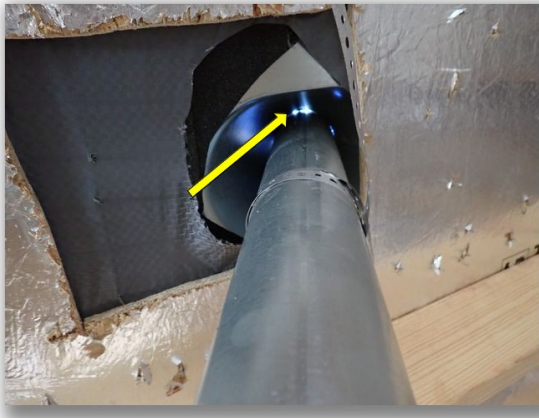
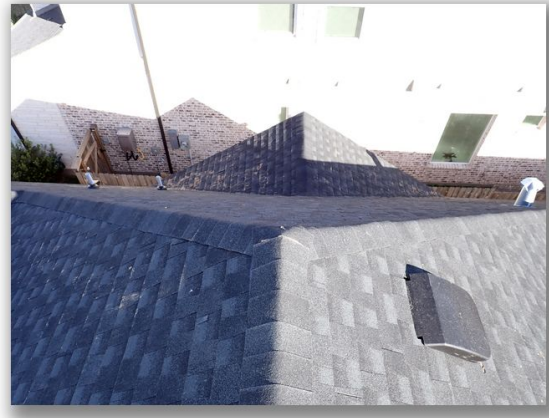
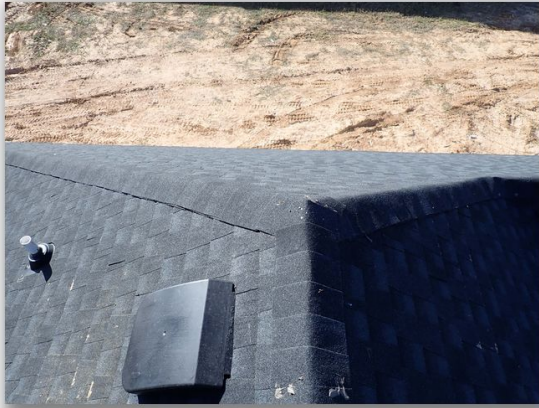
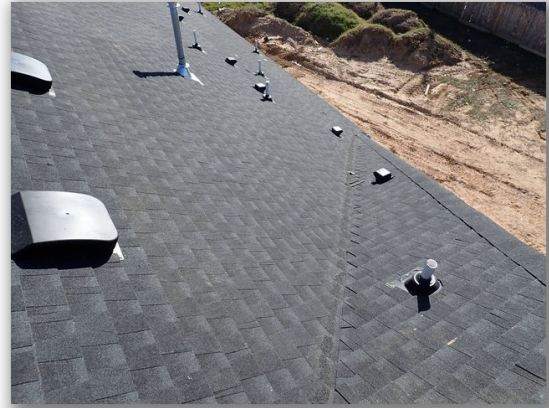
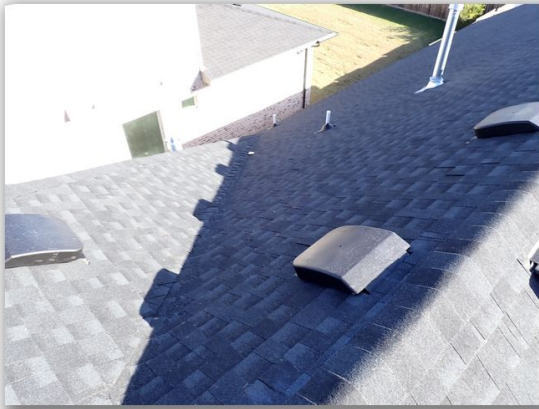
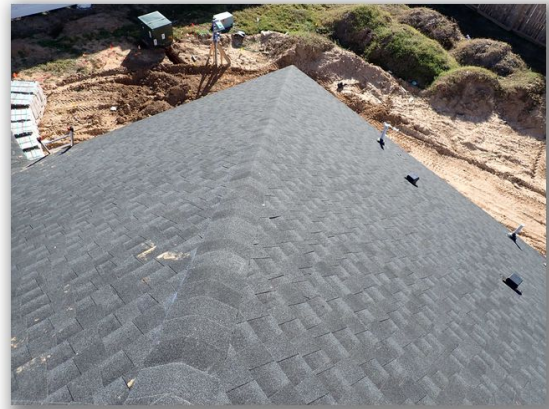
- One or more of the roof level plumbing vent stack flashing details are buckled downward around the plumbing stack. This condition could allow water penetration at this point and corrective measures are recommended.
- It is recommended to paint the flashing details to prevent rust and/or UV damage.
- It is recommended to properly seal the storm collar(s) at the roof level gas equipment vent pipe(s) to help prevent water intrusion into the structure.

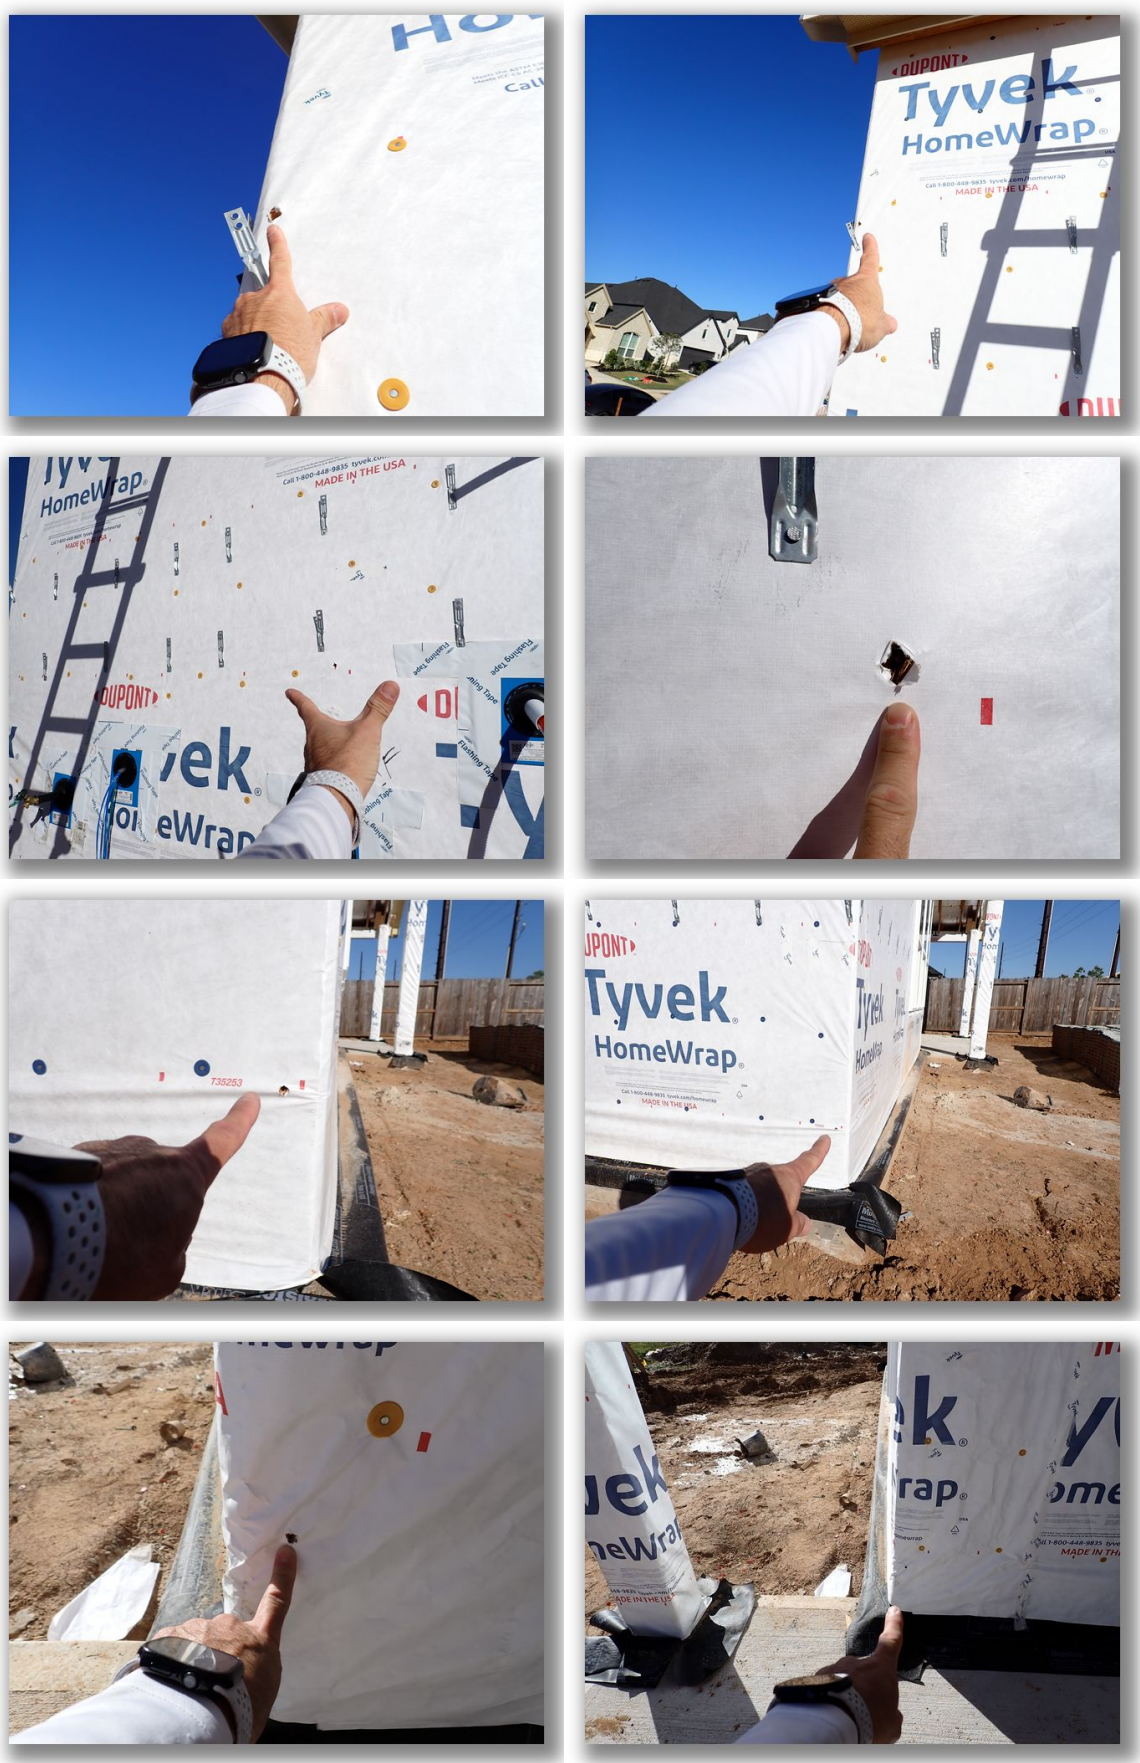
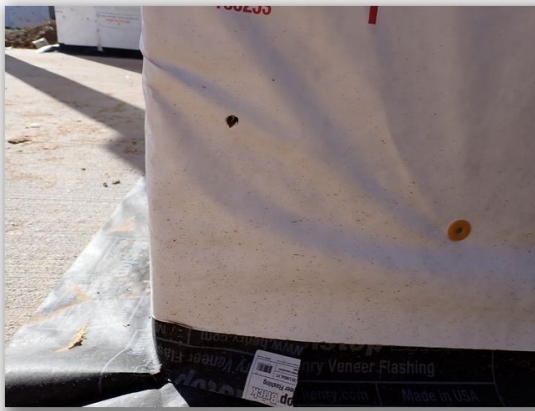
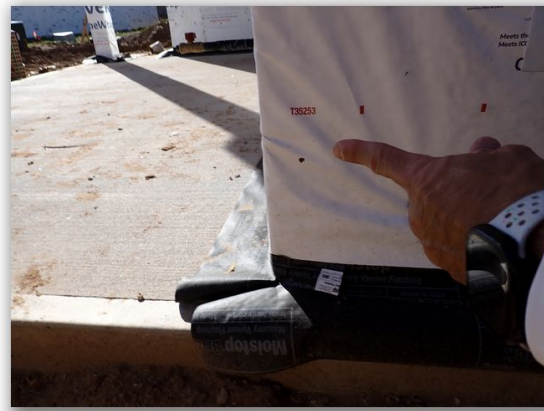
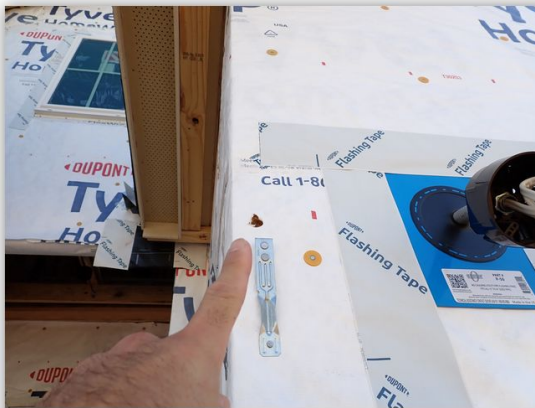
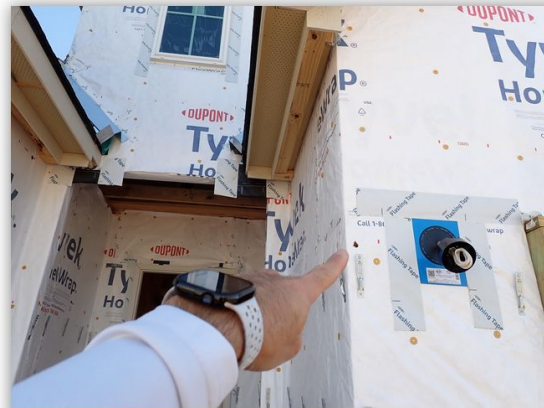
- The holes and/or openings (utility, doors, windows, etc.) in the exterior sheathing / weather barrier should be properly sealed (mastic or tape) on the north, east, west and south sides of the structure.

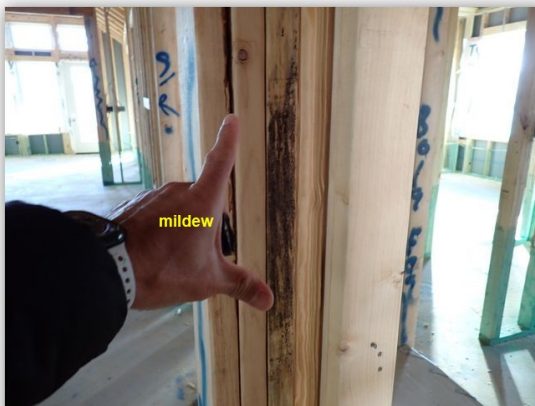
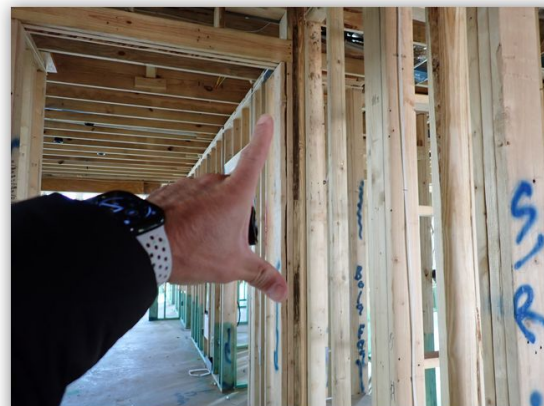
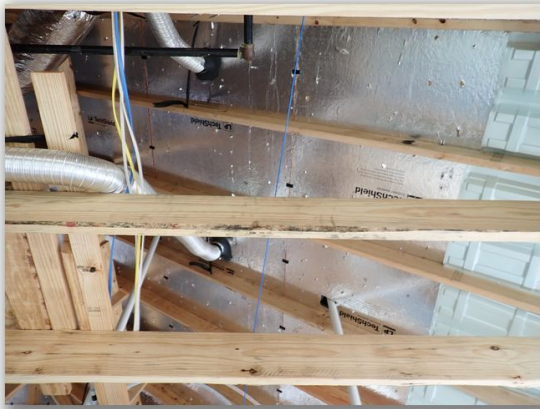
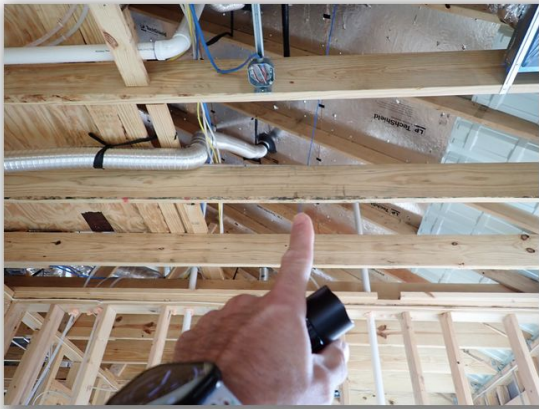
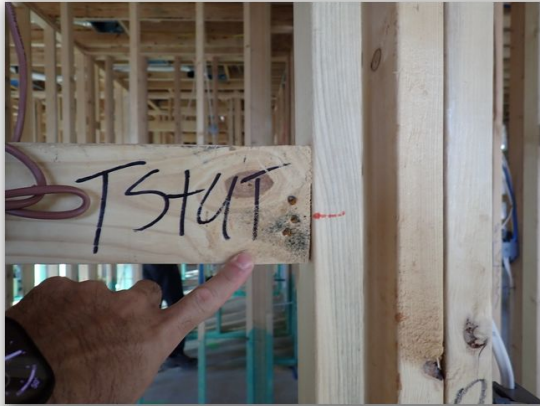
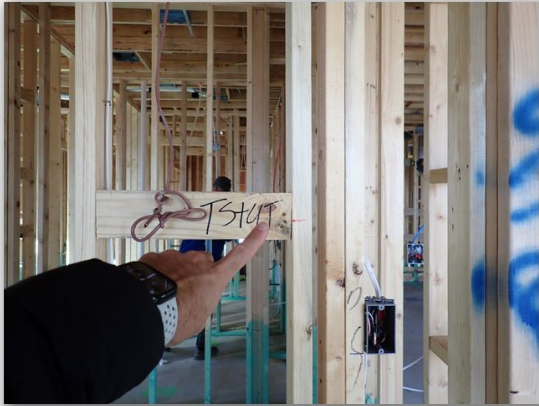
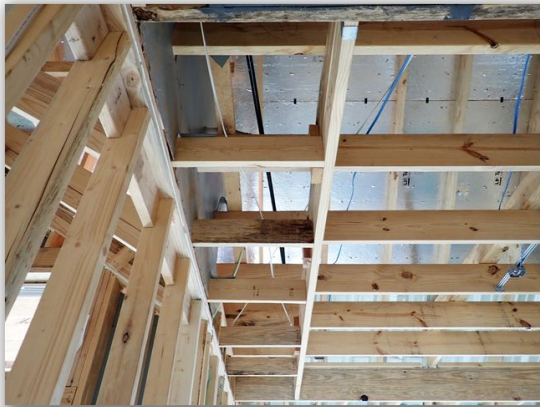
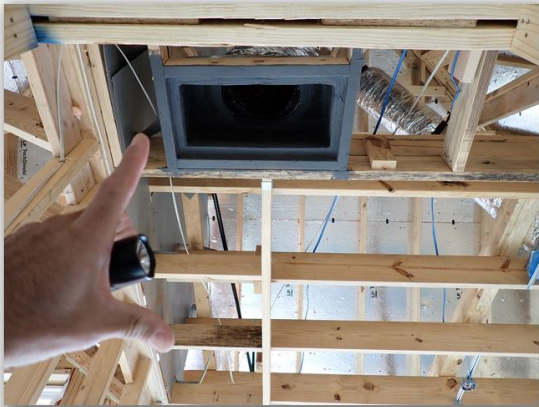
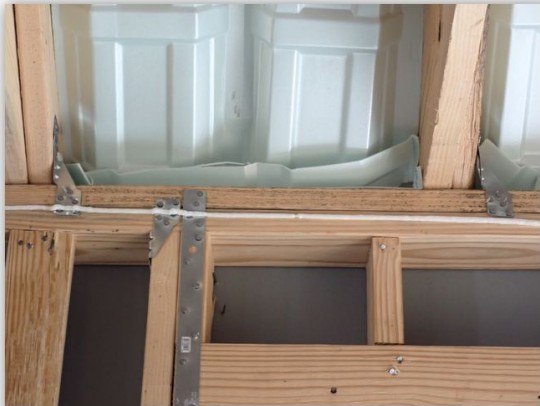
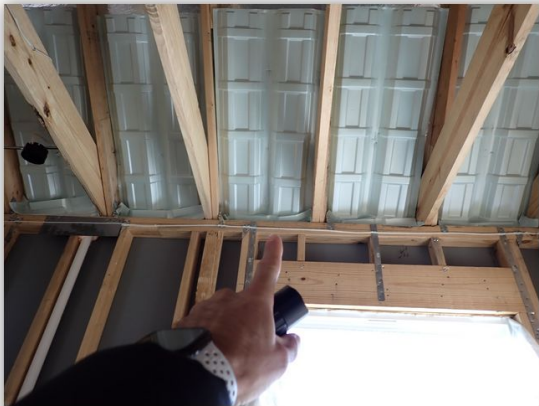
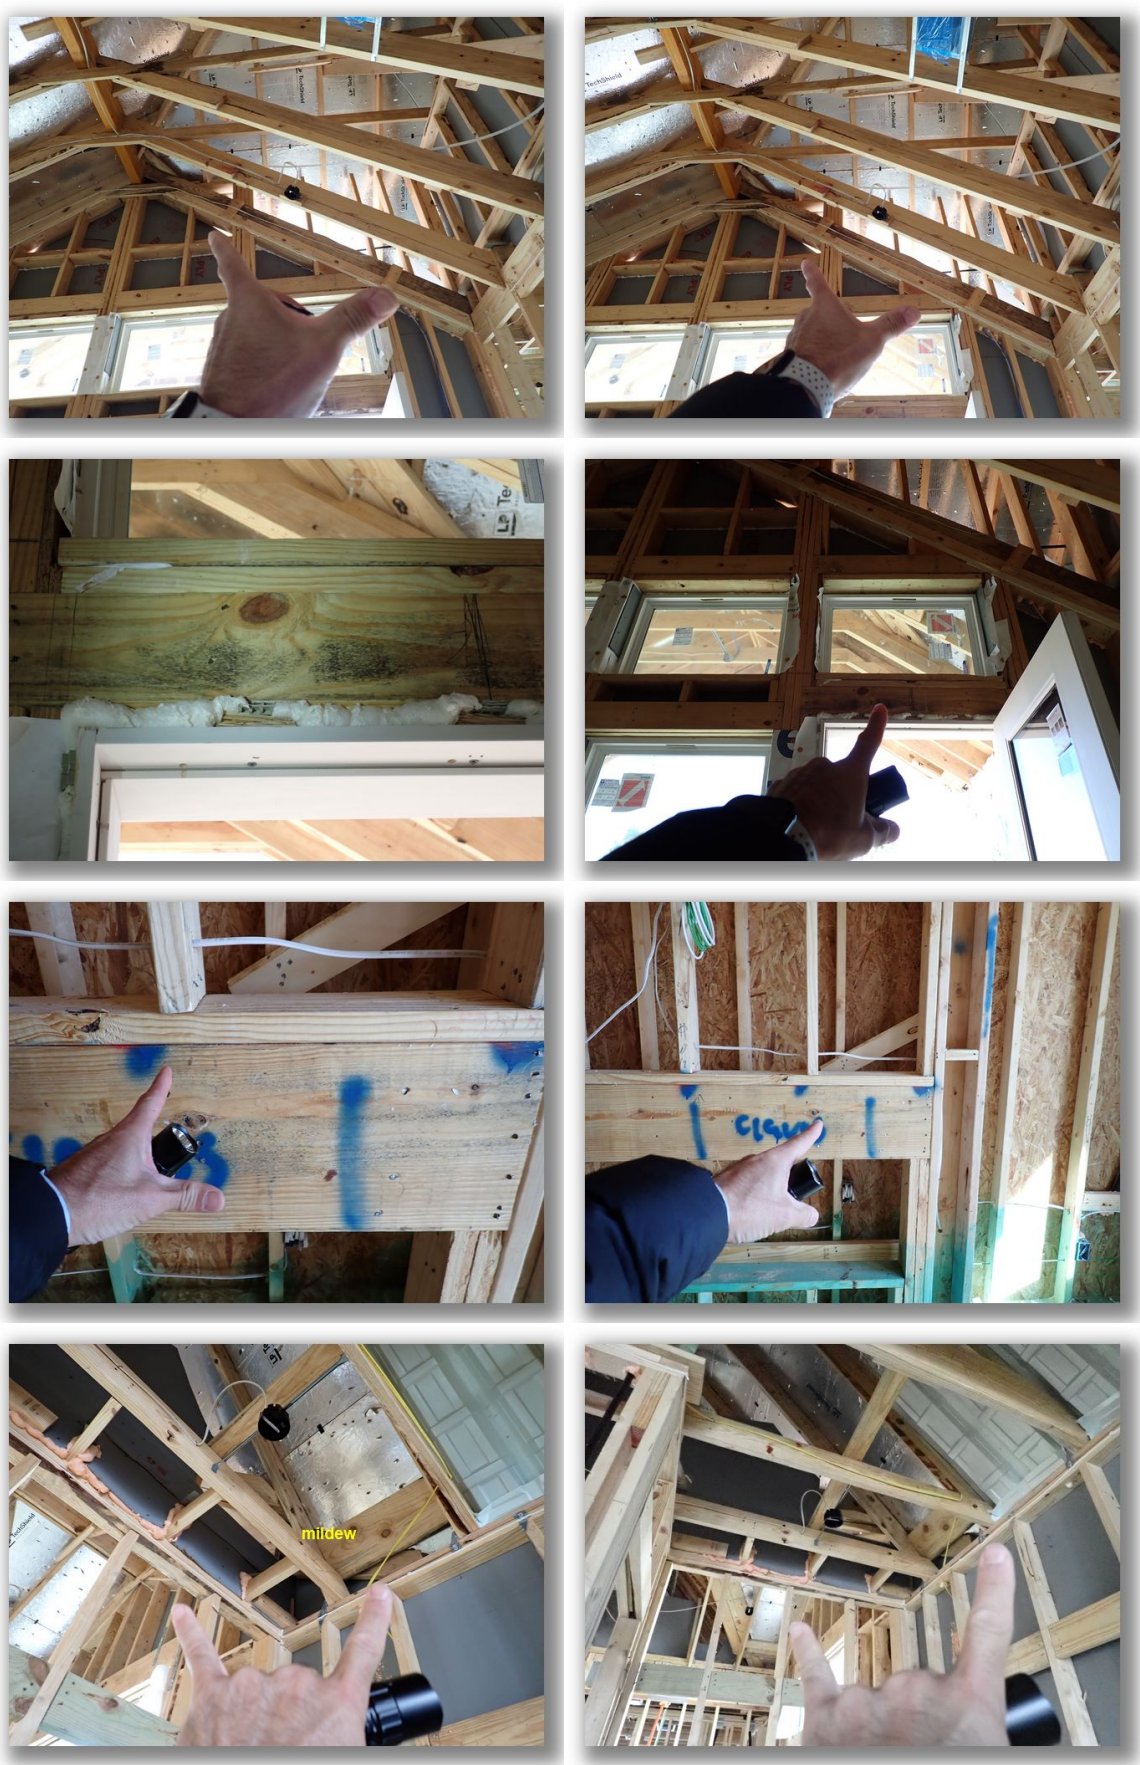
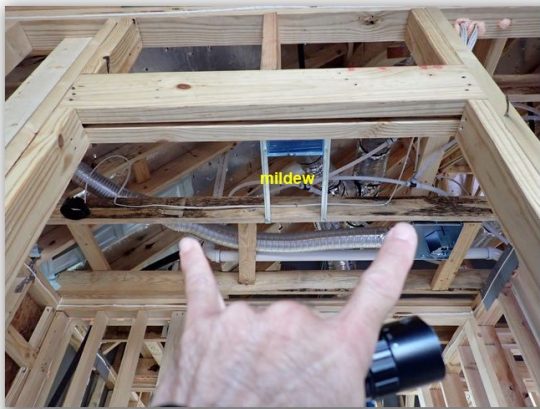
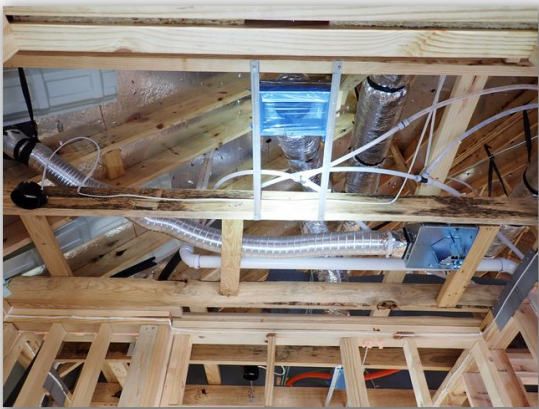
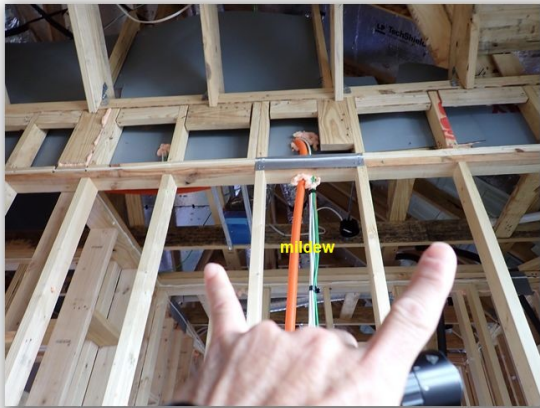
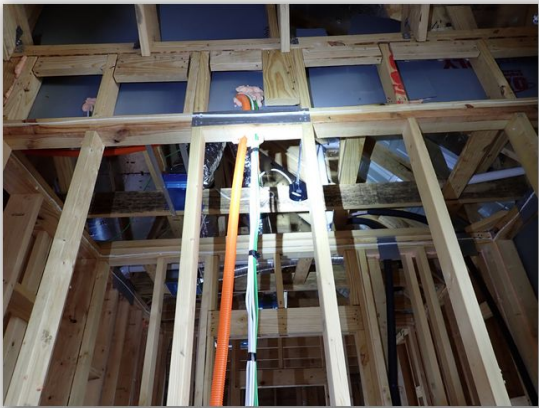
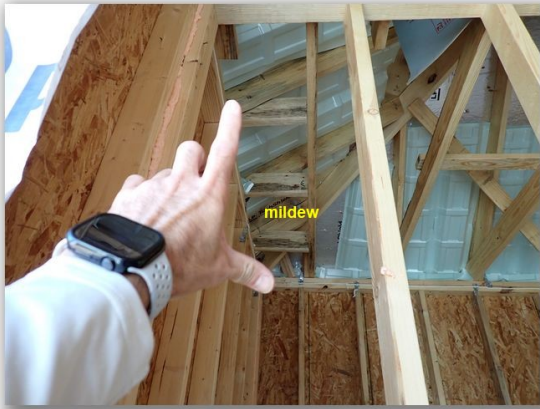
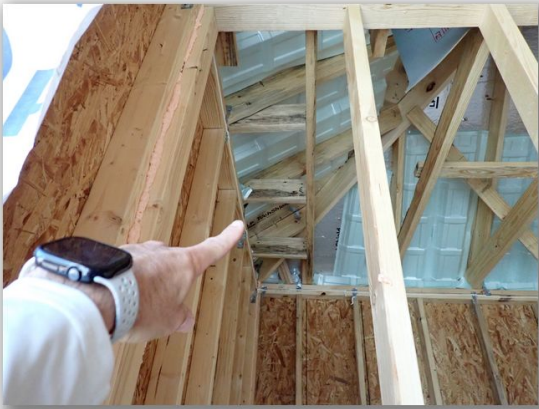
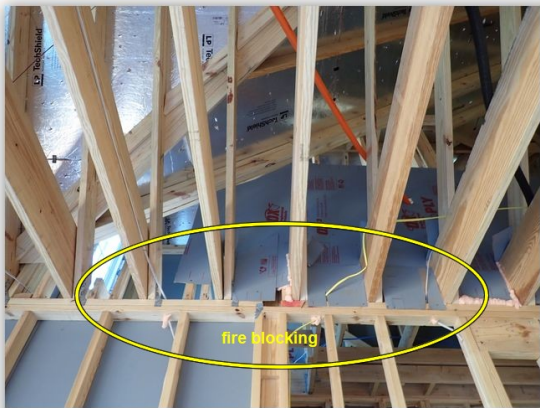
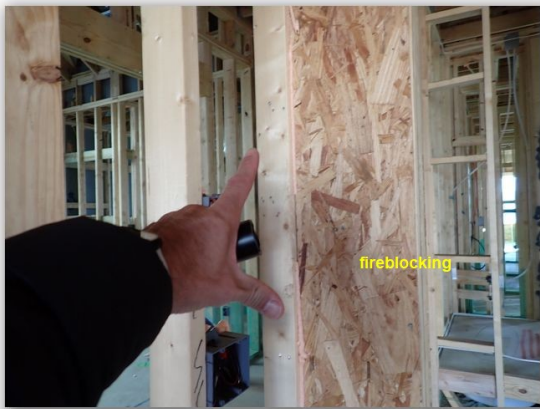
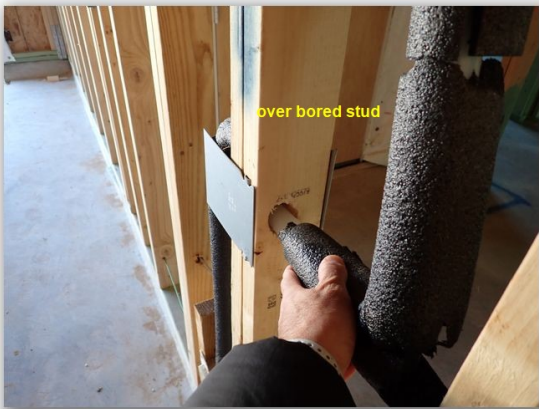
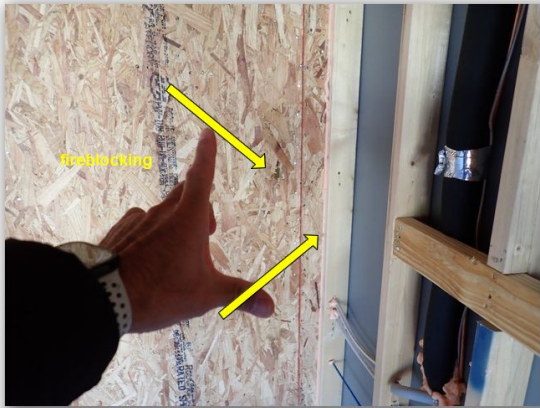
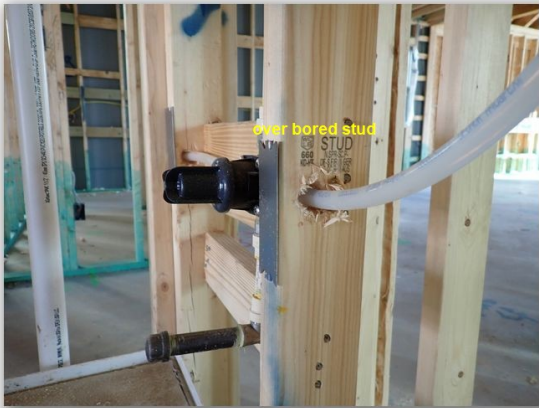
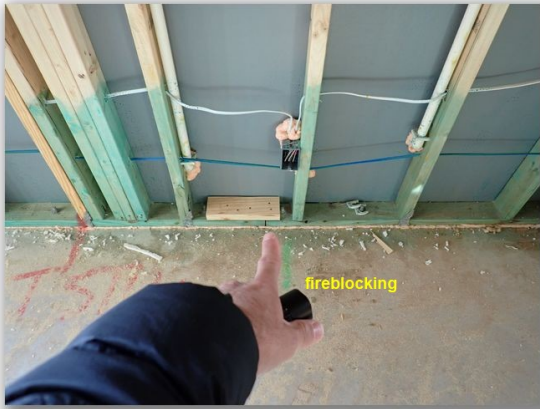
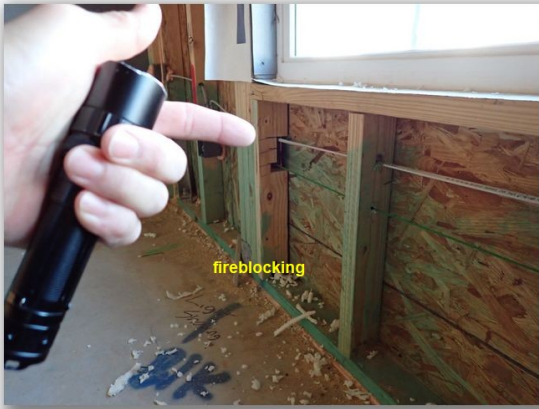
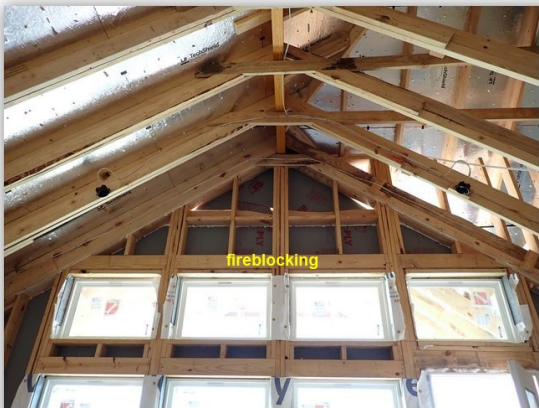
- There was an unknown mold like substance observed in front entry hallway; side middle bedroom; primary bedroom; living room; kitchen; guest bathroom; primary bedroom closet. Evaluation of this substance is beyond the scope of this inspection. If any concerns exist on the type and/or nature of this substance, we recommend further evaluation by a professional in the Air Quality sampling field.

- Improper and/or inadequate fireblocking was observed at the wall void in the garage; side middle bedroom; front corner bedroom; living room. This should be corrected prior to the drywall application.

- The wall studs have been over bored in one or more locations. Under current building standards, the wall studs should not be bored more than 40%. You can bore up to 60% if the wall studs are doubled. It is recommended to correct this issue by doubling up the wall studs in this area or installing a stud boot.

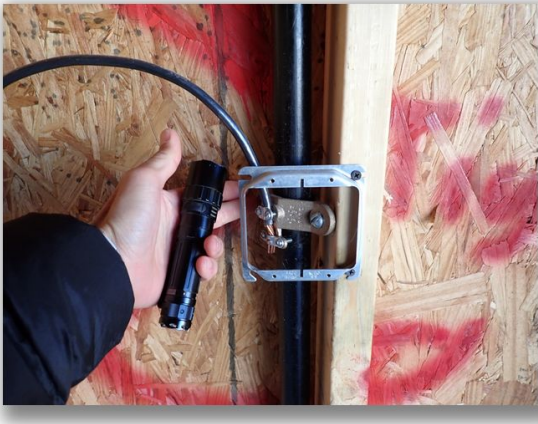
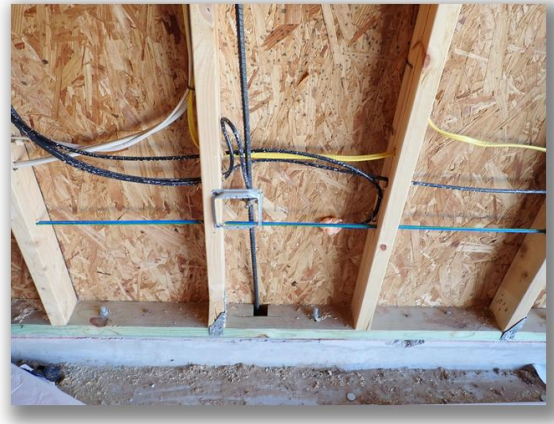
- The clamp for the bonding wire was observed to be loose at the time of inspection.

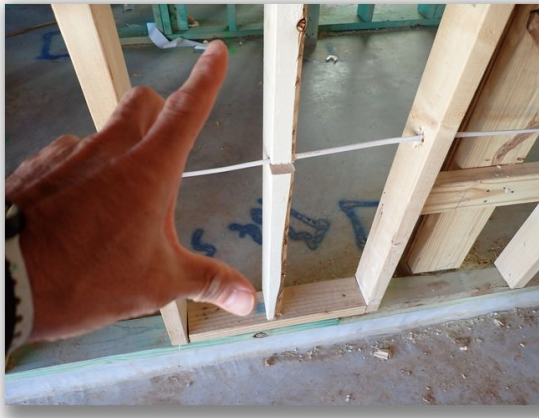
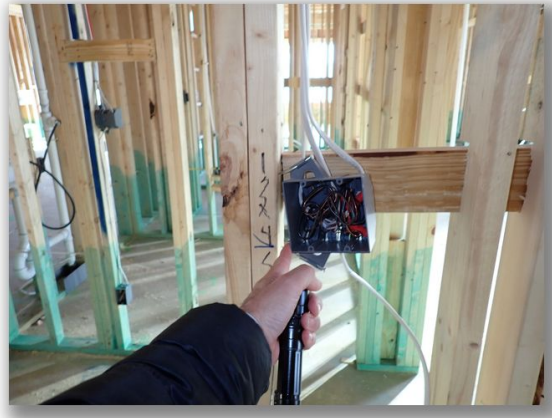
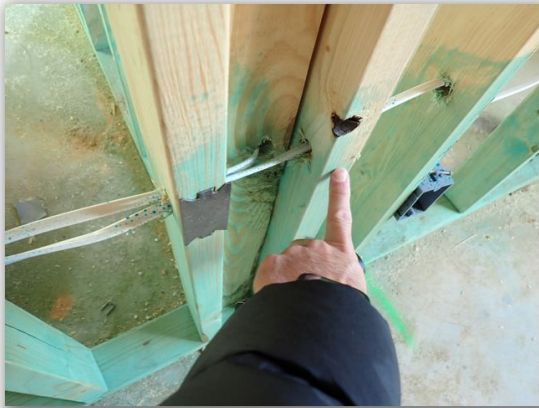
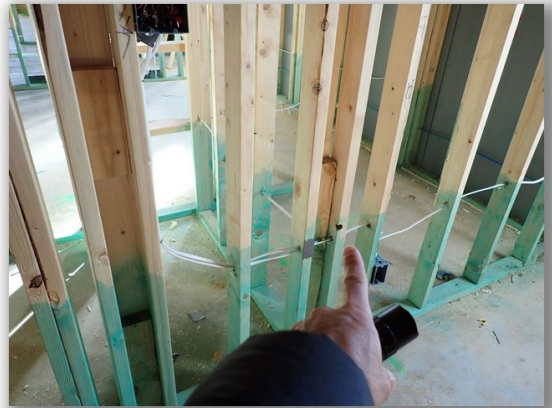
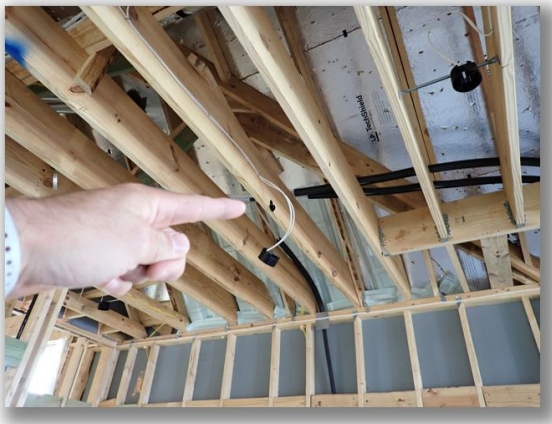
- Nail plates are needed to help protect the electrical branch circuit wiring from fastener (nail or screw) damage in the garage, front corner bedroom.
- The junction box in the hall bathroom is twisted/not level. It is recommended to straighten the junction box prior to sheetrock installation.
- One of the junction boxes in the kitchen was observed to be damaged at the time of inspection.

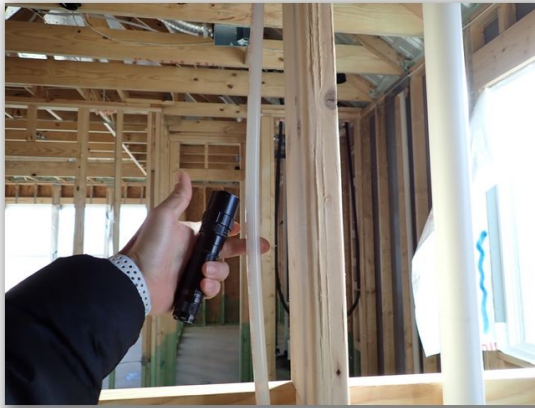
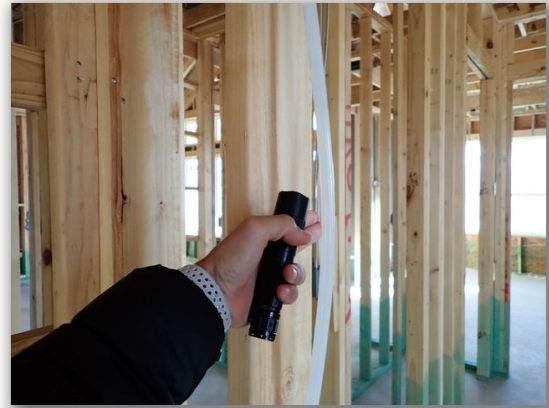
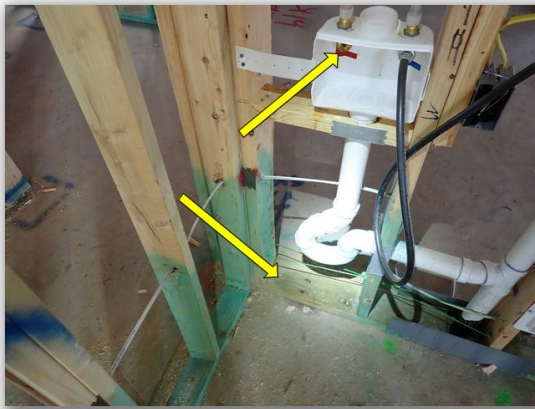
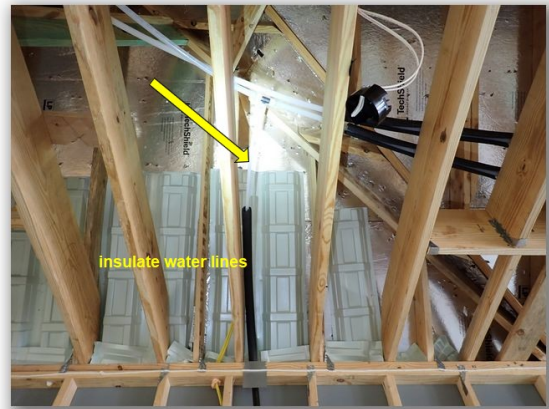
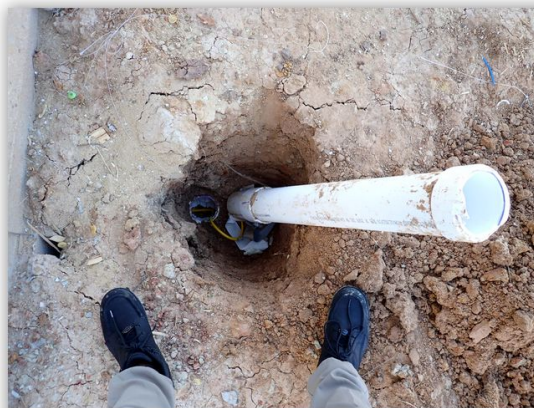
- The plumbing fixture assembly and plumbing lines are not properly secured in place in the primary bathroom. This will help prevent hammering and water line knocking.
- There is a visible water leak in the water supply line in the laundry room.
- One or more plumbing supply lines are not properly insulated. Under current building standards, all water supply lines that are within 5 feet of the exterior walls should be insulated to prevent freeze damage.
- The main drain line clean out is not capped at the time of inspection. The main clean out should be capped to prevent debris from creating a blockage in the main drain line.
- The main drain line clean out was observed to be broken at the time of inspection. This condition should be further evaluated.

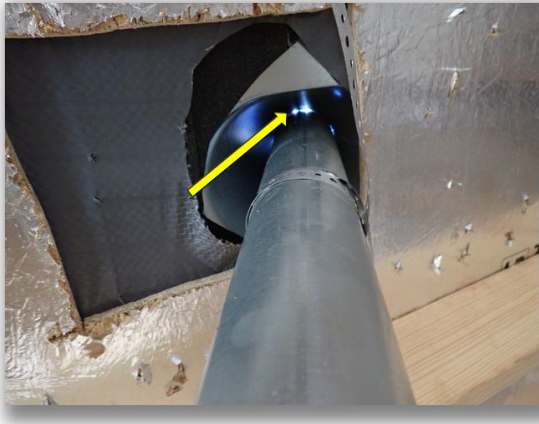
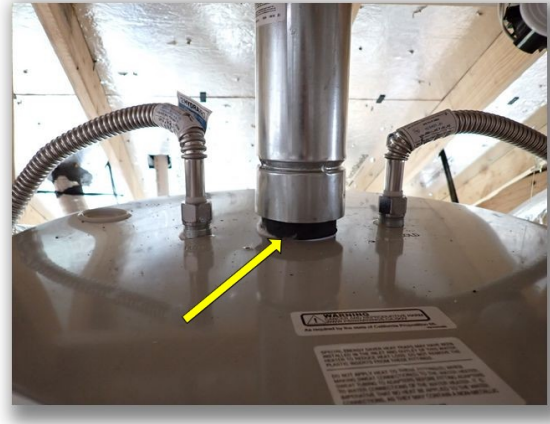
- The roof level flue storm collar should be properly sealed to help prevent water intrusion into the structure.
- The vent pipe is not properly mounted at the top of the water heater. This configuration will emit Carbon Monoxide into the attic area, which is a known safety hazard.
