**Sample Report**  
**1234 Sample Report**  
**Richmond, TX 77406**

**January 14, 2026**

# PROPERTY INSPECTION REPORT FORM

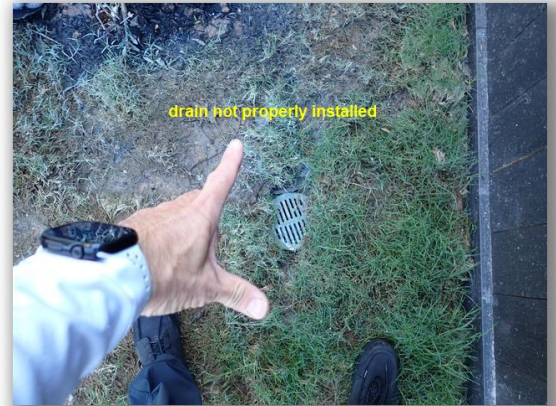
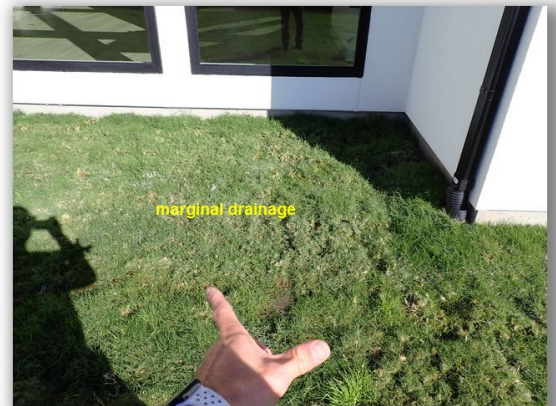
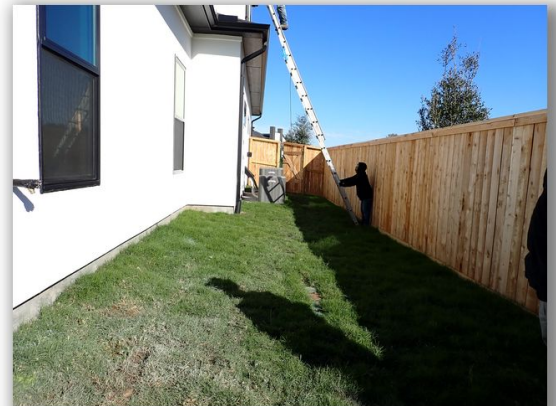
- Marginal site drainage was observed on the south side, east side, west side of the structure. Proper drainage is needed to help prevent water from standing and/or ponding next to the foundation beam. Corrective measures may be needed if the water stands within 10-feet of the foundation perimeter beam for more than 24-hours.
- It is recommended to roll and smooth out all depressions in the grade at the time of inspection.
- One or more of the surface drain(s) are not properly installed. Repairs are recommended to ensure proper operation of the surface drain system.
- **Poor to negative site drainage** was observed on the west side of the structure. Proper drainage is needed to help prevent water from standing and/or pooling next to the foundation beam. Corrective measures may be needed if the water stands within 10-feet of the foundation perimeter beam for more than 24-hours.

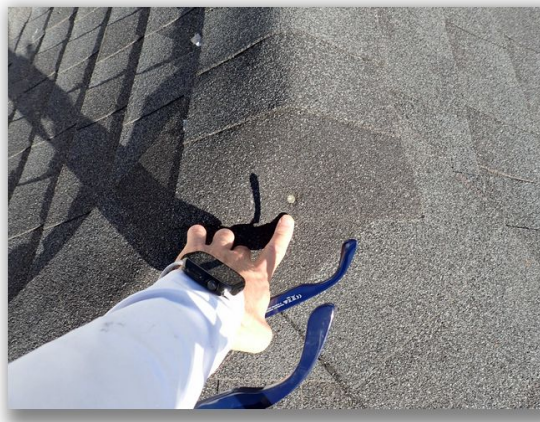
- Improper roofing fasteners were observed at the time of inspection.

**Note:** Roof fasteners (nails and/or staples) were observed to be exposed and should be properly sealed at the ridge caps and flashing areas.

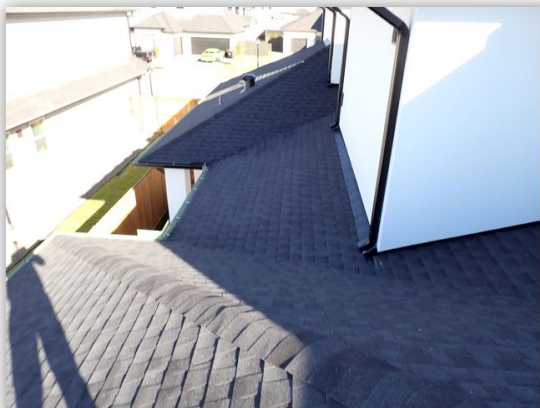
**Flashing Details**

You are strongly encouraged to have a properly certified roofing contractor to physically inspect the roof, prior to the expiration of any time limitations such as option or warranty periods, to fully evaluate the condition of the roofing material. The observation made to support the rendering of this opinion are listed but not limited to the following:

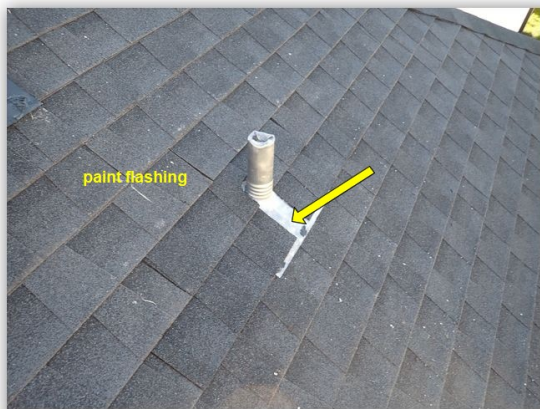
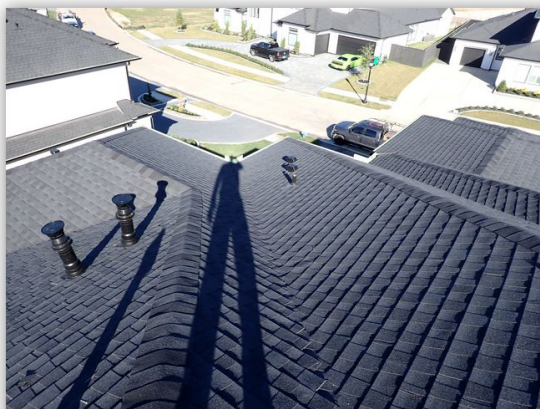
- It is recommended to paint the flashing details to prevent rust and/or UV damage.

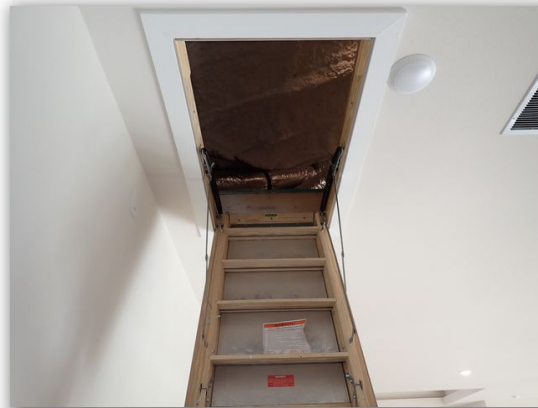
- Some of the attic ladder nuts and bolts were observed to be loose and/or missing. Improvements to the attic ladder are recommended for reasons of safety.

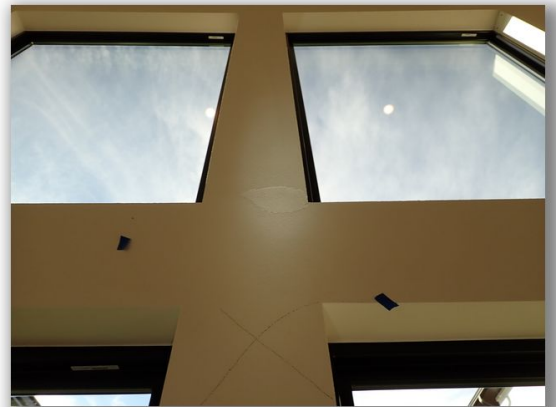
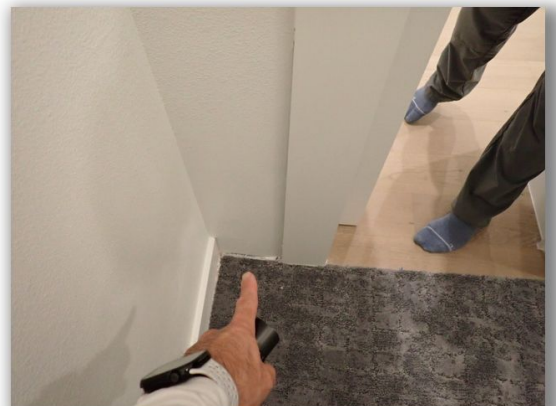
- Paint touch ups are recommended in several locations at the time of inspection.
- Several locations of cosmetic repair (texture, caulk, paint) are recommended.
- Interior wall joint cracks were observed in the several locations throughout the house.
- The wall texture has some deterioration and/or damage in the several locations throughout the house.
- The baseboards were observed to be missing in the upstairs primary bathroom closet closet.

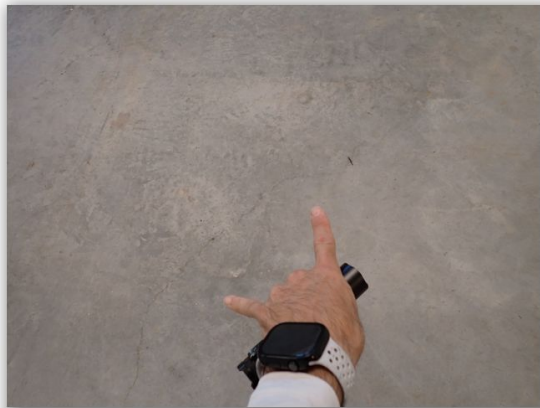
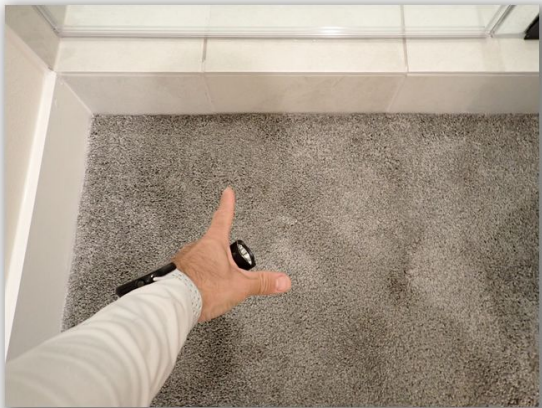
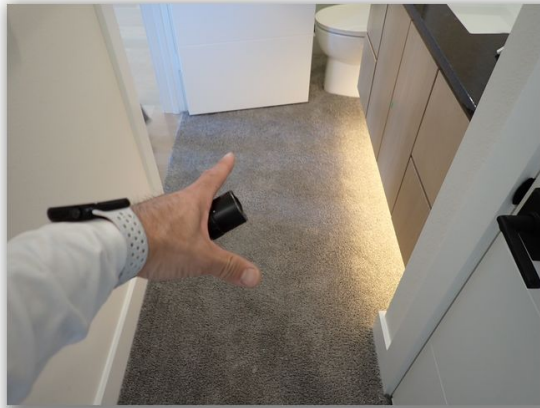
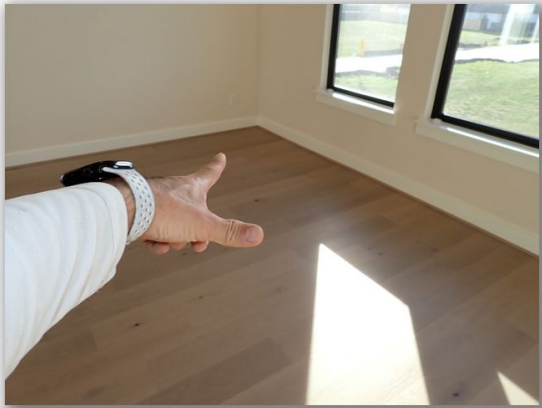
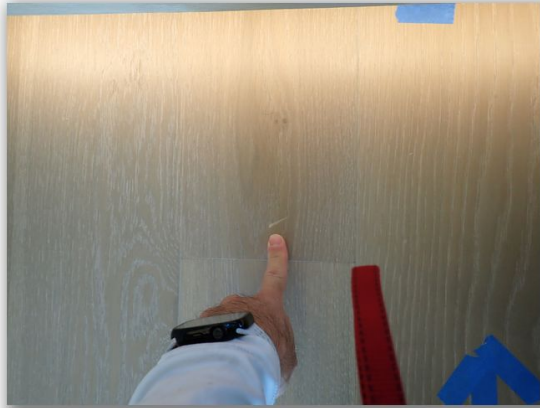
- Paint touch ups are recommended in several locations at the time of inspection.
- Several locations of cosmetic repair (texture, caulk, paint) are recommended.
- Ceiling joint cracks were observed in the kitchen.

- The floor covering is stained in one or more locations of the home.
- The floor covering was observed to be damaged in the stairway; upstairs primary bedroom.
- The floors were observed to be out-of-level in some areas of the house.

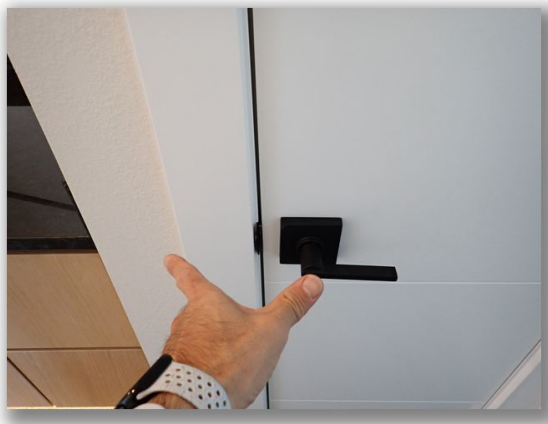
- The door is not latching properly to the upstairs front middle bedroom bathroom closet, upstairs side middle bedroom bathroom closet, primary bedroom.

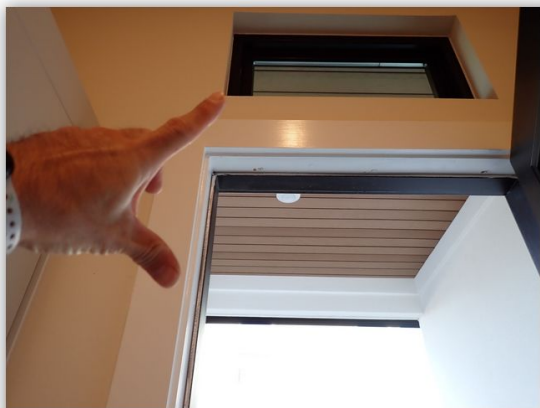
- Weather-stripping improvements are recommended for the kitchen exterior door(s).
- The door hardware for the garage entry door was observed to be noisy at the time of inspection.

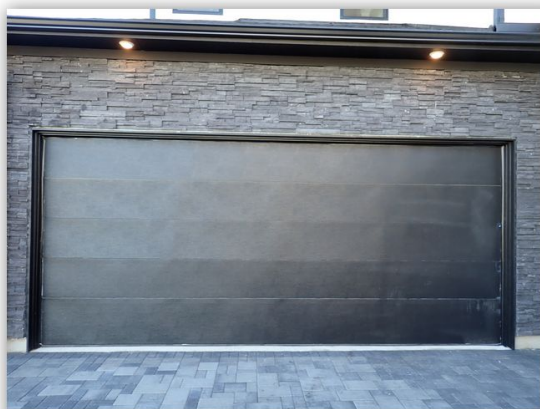
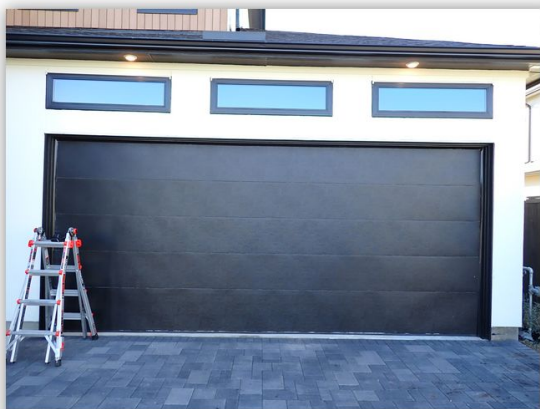
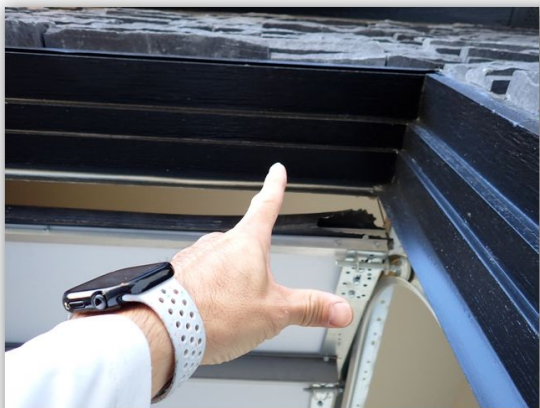
**Overhead Garage Door**

- The weather-stripping for the overhead garage door is damaged and repairs or replacement may be needed.

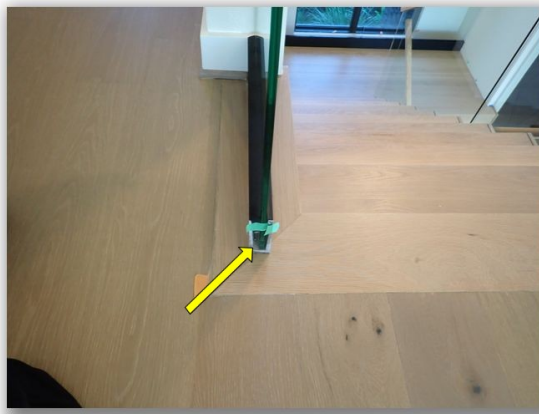
- The cover plate for the ends of the stair rails was observed to be missing at the time of inspection.

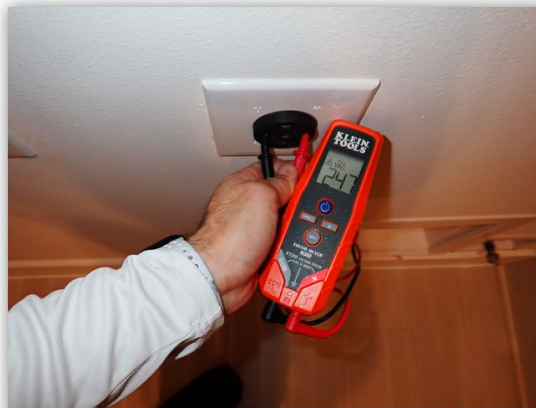
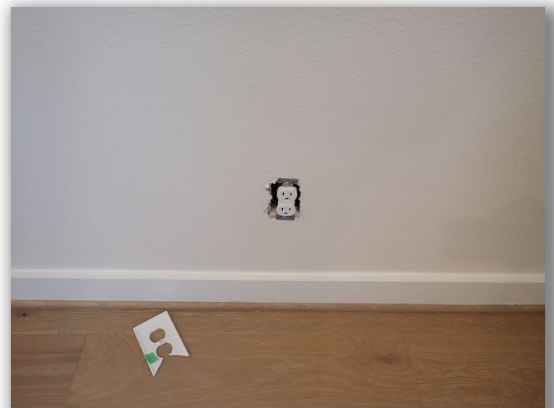
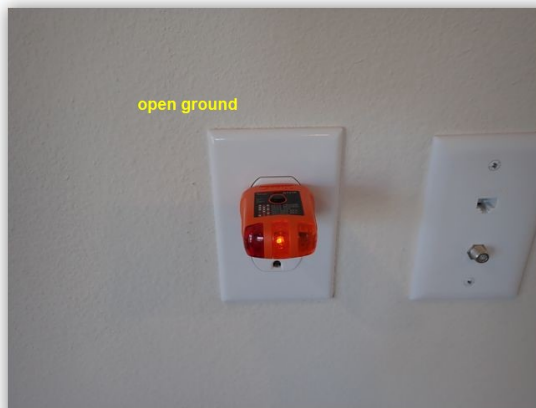
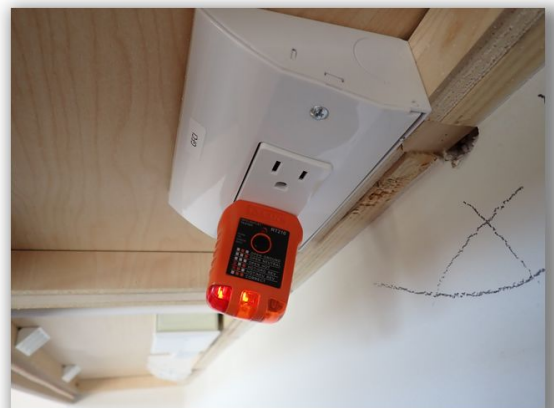
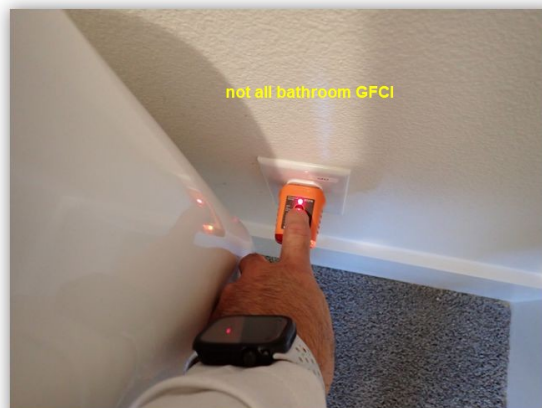
- One or more of the receptacle cover plates are damaged in the upstairs front corner bedroom.
- One or more of the receptacles were observed to have an open ground connection in the upstairs front middle bedroom.

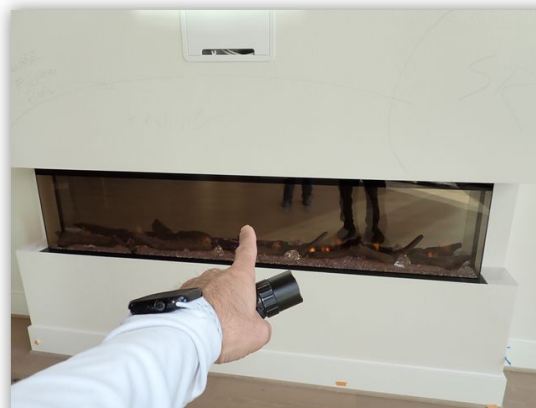
#### Fixtures

- One or more of the light fixtures are inoperative in the upstairs primary bedroom. This may be due to a bad bulb or some other unknown condition. This condition should be further evaluated and corrected as necessary.
- The electric heater was observed to not function properly at the time of inspection.

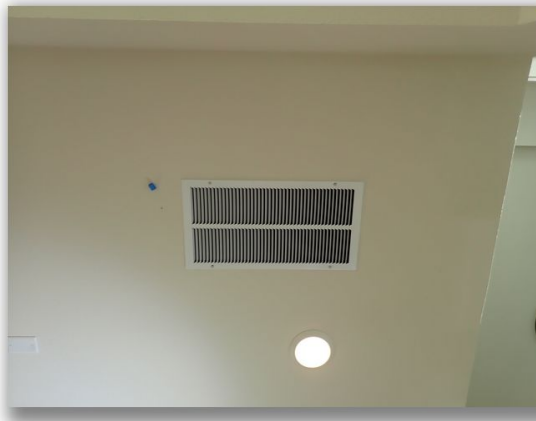
- The return air intake register for the heating and cooling system is in a poor location. The return air intake register is currently located in the kitchen.

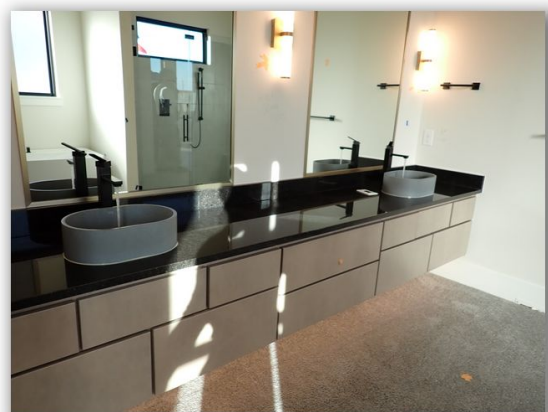
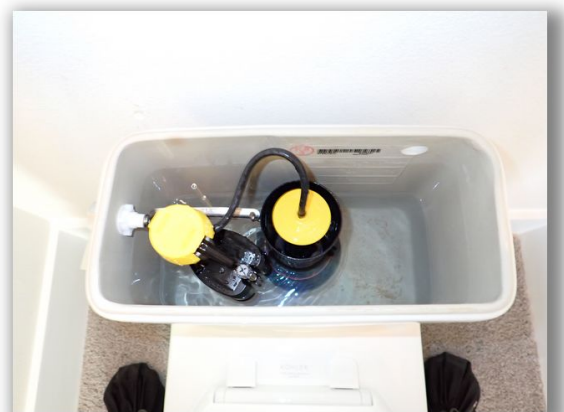
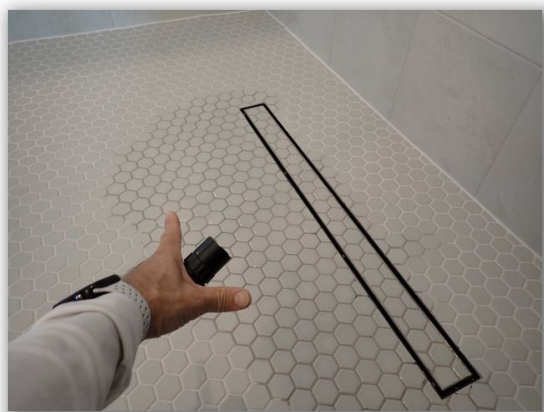
**Primary Bathroom**  
*Shower*

- The slope of the shower pan was observed to be improper due to water being held at the time of inspection.

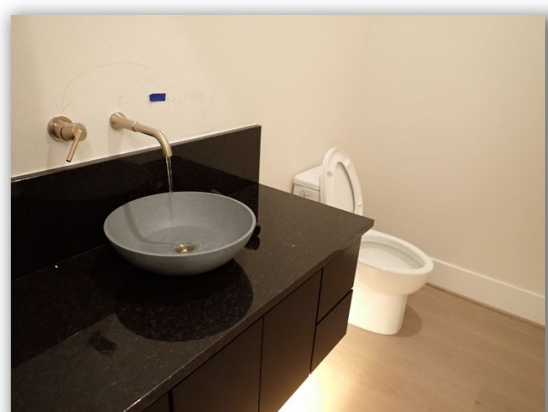
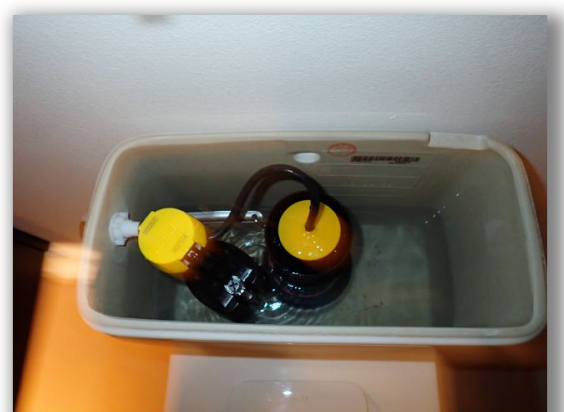
**Downstairs Half Bath**

- There are no water supply shutoff valves for this fixture.

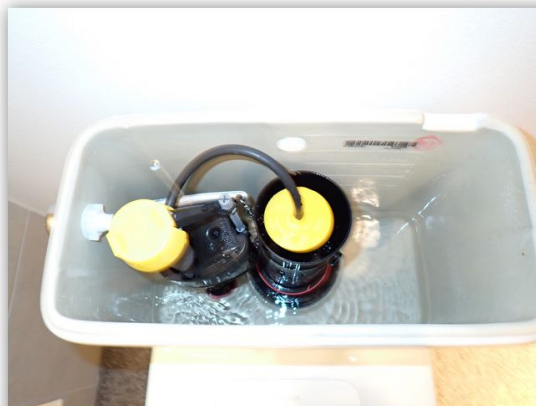
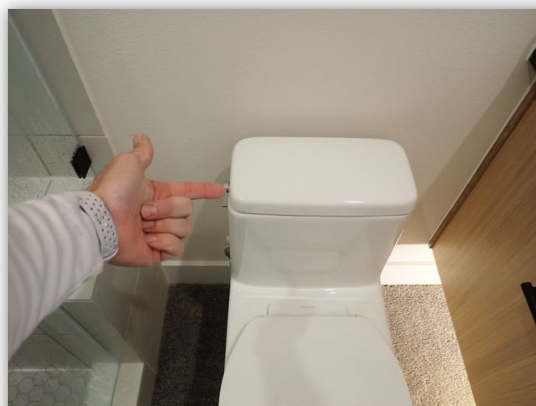
#### **Upstairs Front Middle Bedroom Bathroom**

- The undermount sink is not properly supported and is currently only held up with adhesive. It is recommended to add support to prevent future damage.
- The primary drain line terminating into the sink was observed to be leaking at the time of inspection.

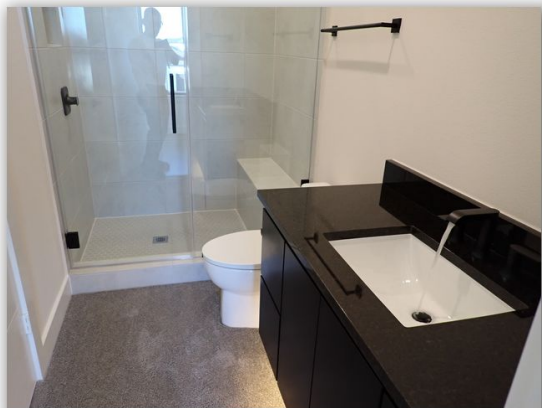
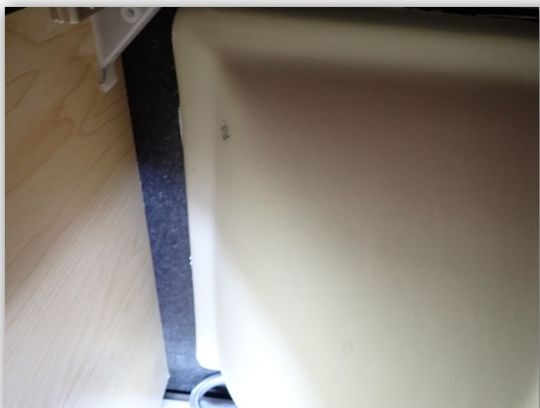
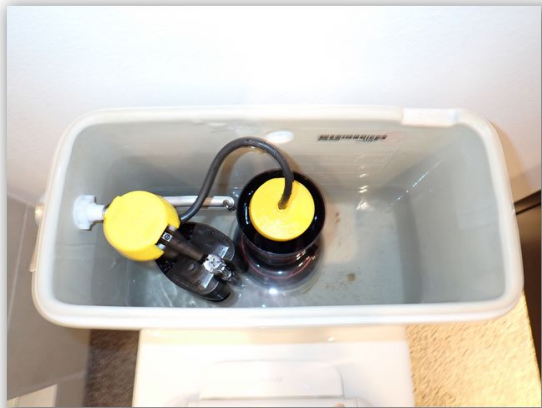
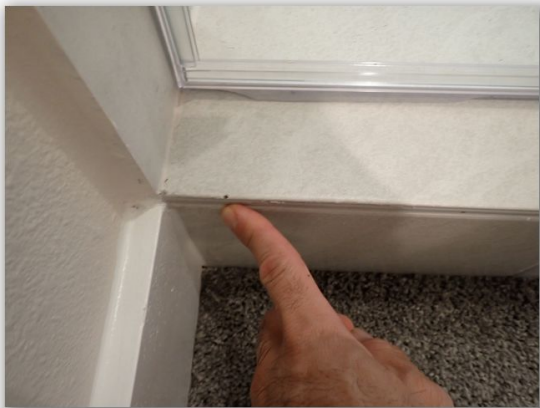
### Upstairs Front Corner Bedroom Bathroom

- The undermount sink is not properly supported and is currently only held up with adhesive. It is recommended to add support to prevent future damage.

- Some of the enclosure tiles were observed to be cracked.

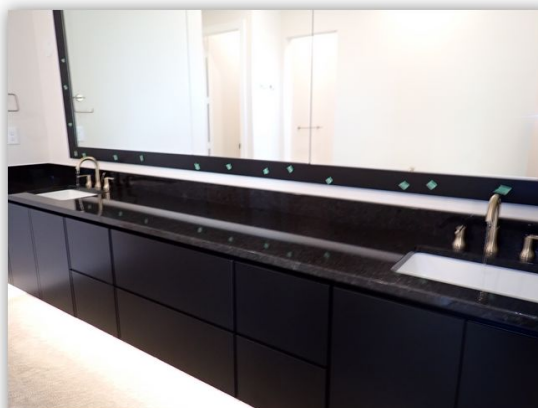
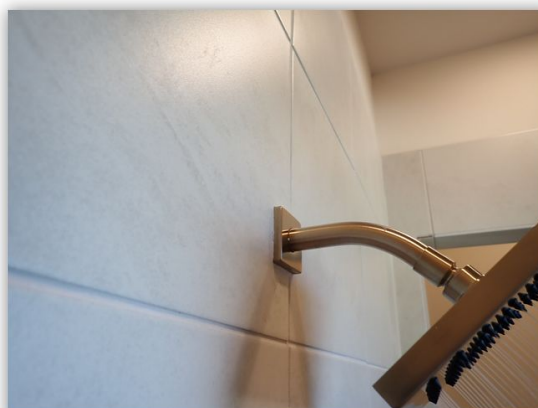
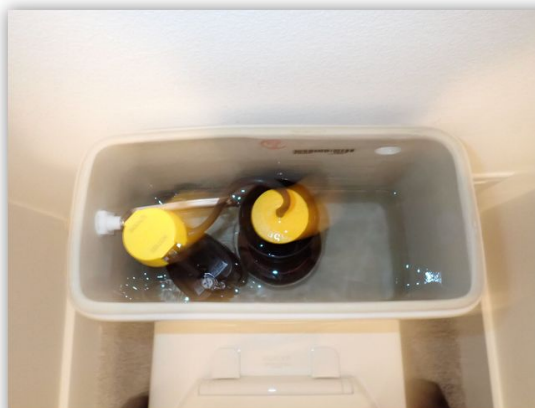
#### *Shower*

- Cracked, deteriorated and/or missing grout and/or caulking should be repaired or replaced as necessary.
- The slope of the shower pan was observed to be improper due to water being held at the time of inspection.

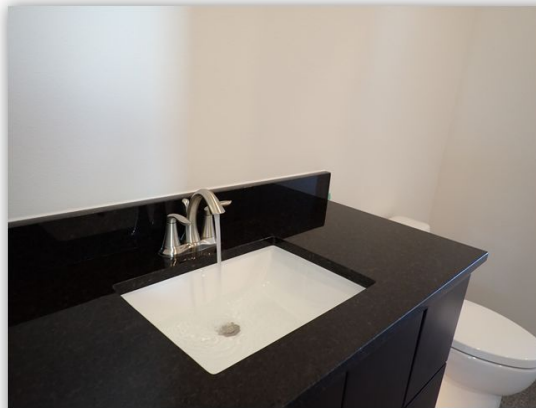
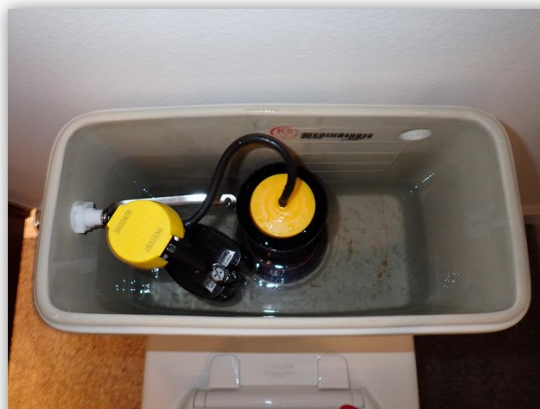
**Upstairs Rear Corner Bedroom Bathroom**

- The undermount sink is not properly supported and is currently only held up with adhesive. It is recommended to add support to prevent future damage.

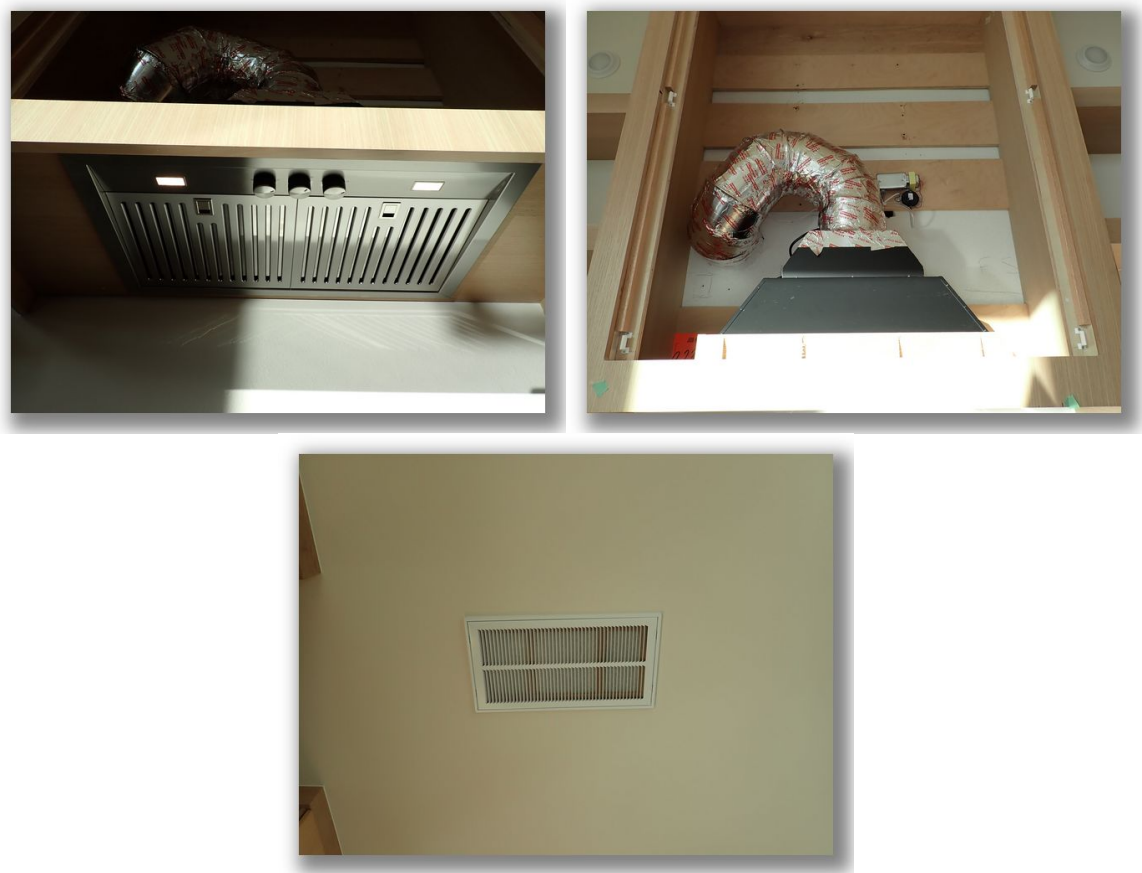
- The range hood cover was observed to be missing at the time of inspection.

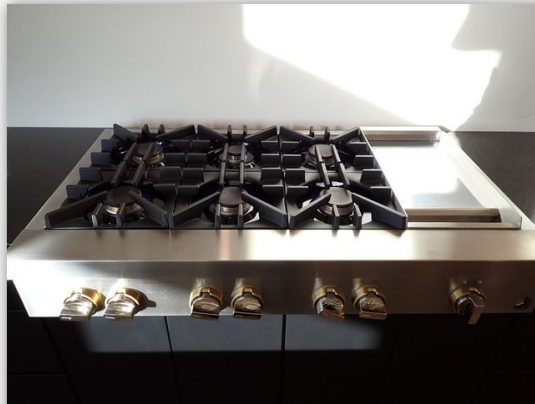
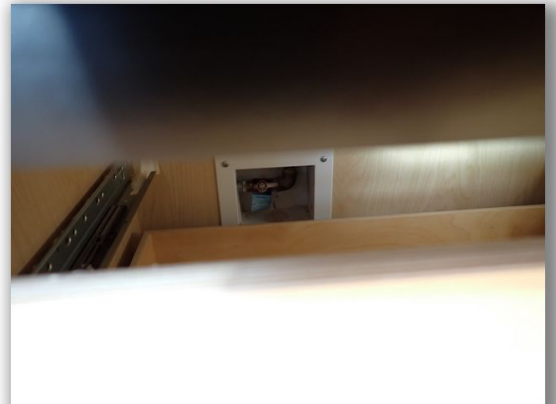
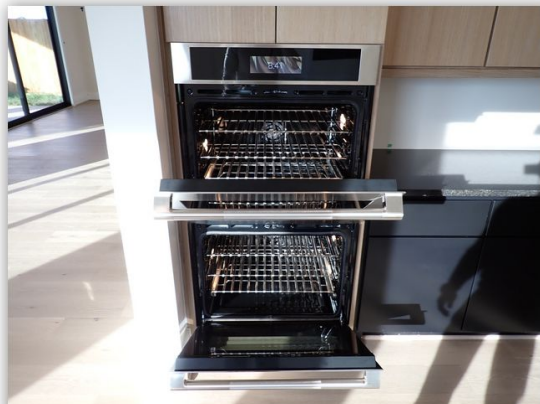
- The gas shutoff valve is in a poor location and is hard to reach.

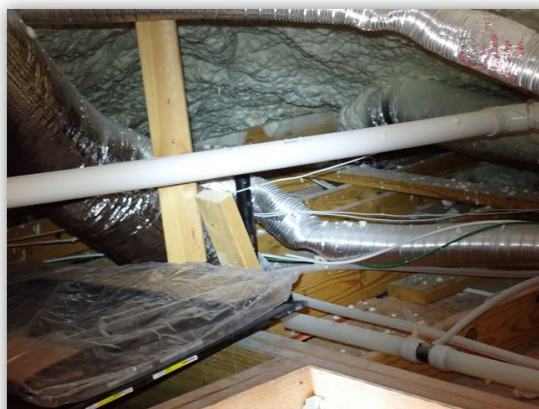
- The ducting to one of the mechanical exhaust fans was observed to be damaged in the attic area over the upstairs front corner bedroom bathroom.

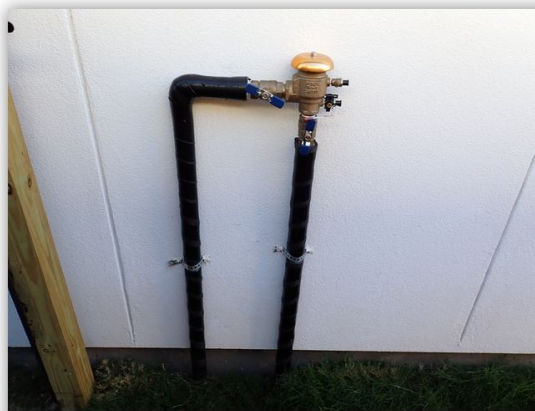
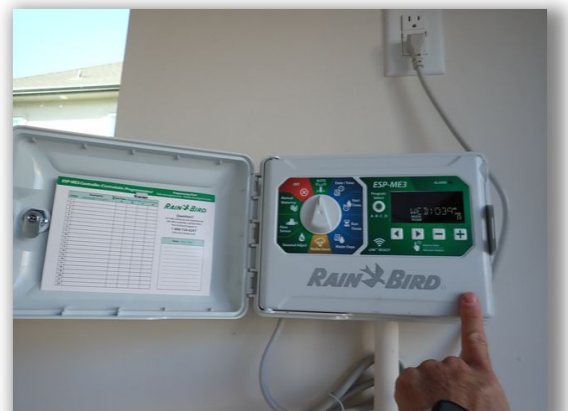
- One or more of the sprinkler heads should be adjusted so not to disperse water onto concrete flatwork (such as; roadways, sidewalks, porches, patios or driveways) in station(s); **1, 2, 3, 4, 5, 9.**
- One or more of the sprinkler heads should be adjusted so not to spray water onto the exterior walls, surfaces or windows in stations; **2, 4, 10, 9.**
- Sprinkler station(s) **11** did not respond when tested in the manual setting. The cause and remedy should be further evaluated and corrected as necessary.

**Note:** Due to the limited nature of a general home inspection, it is possible that additional deficiencies will be discovered by a licensed technician. It is recommended to have the system serviced prior to the expiration of any option/warranty period.
