**PHASE 1  
PRE-POUR INSPECTION REPORT**

INSPECTED FOR  
**Sample Report**  
**1234 Sample Report**  
**Spring, TX 77386**

**December 16, 2025**

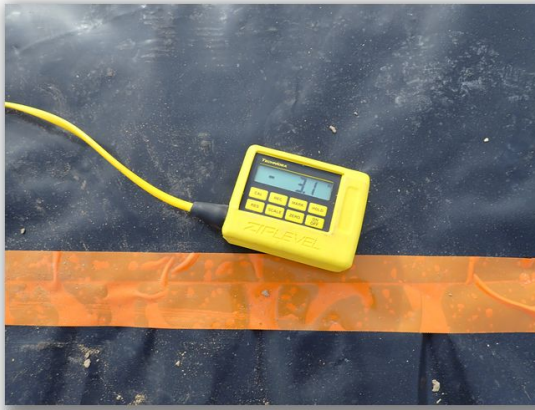
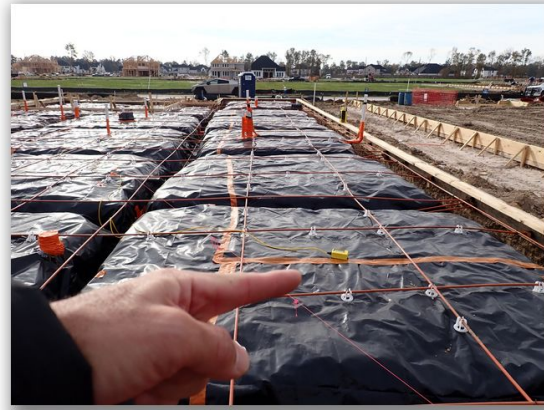
- The slab thickness is not a minimum of 3.5-inches in the living room.

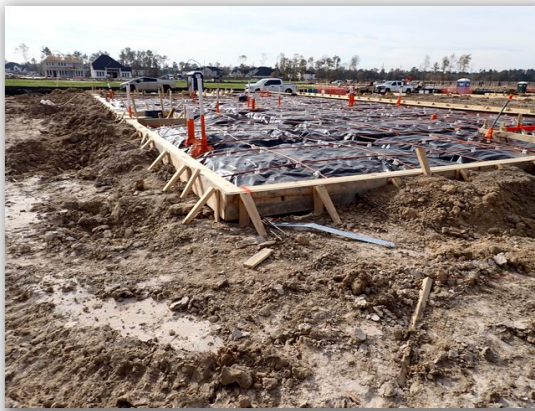
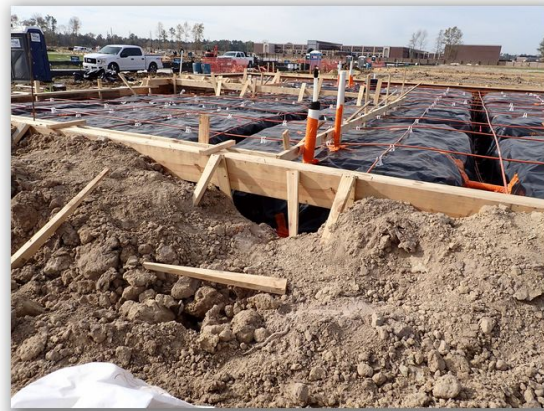
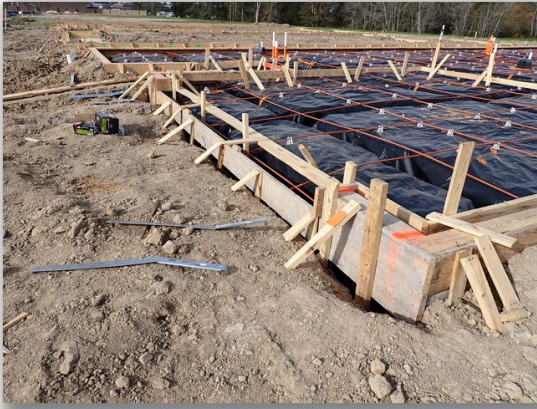
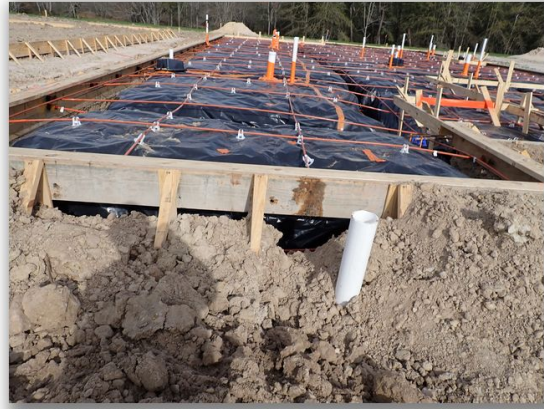
- The form boards are not properly backfilled to help prevent blowouts on the north side, east side, south side of the foundation.

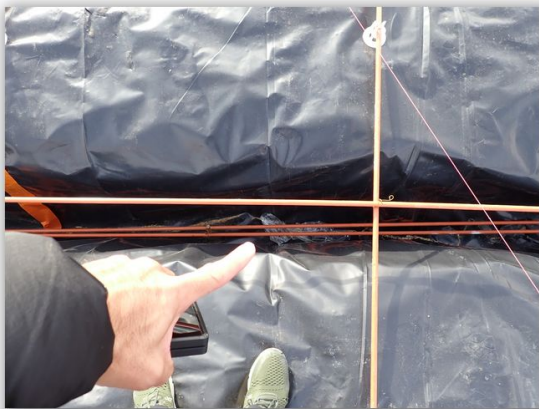
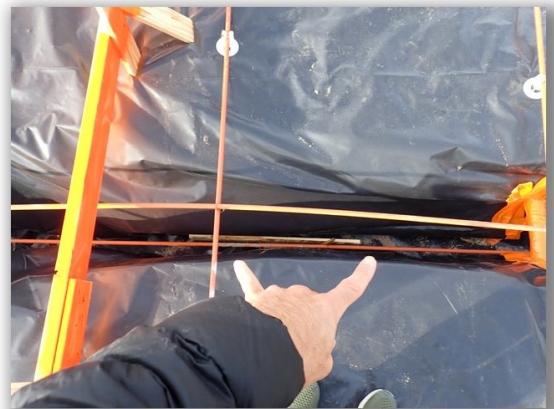
- All debris in the foundation beam trenches should be cleaned out before the concrete is poured.

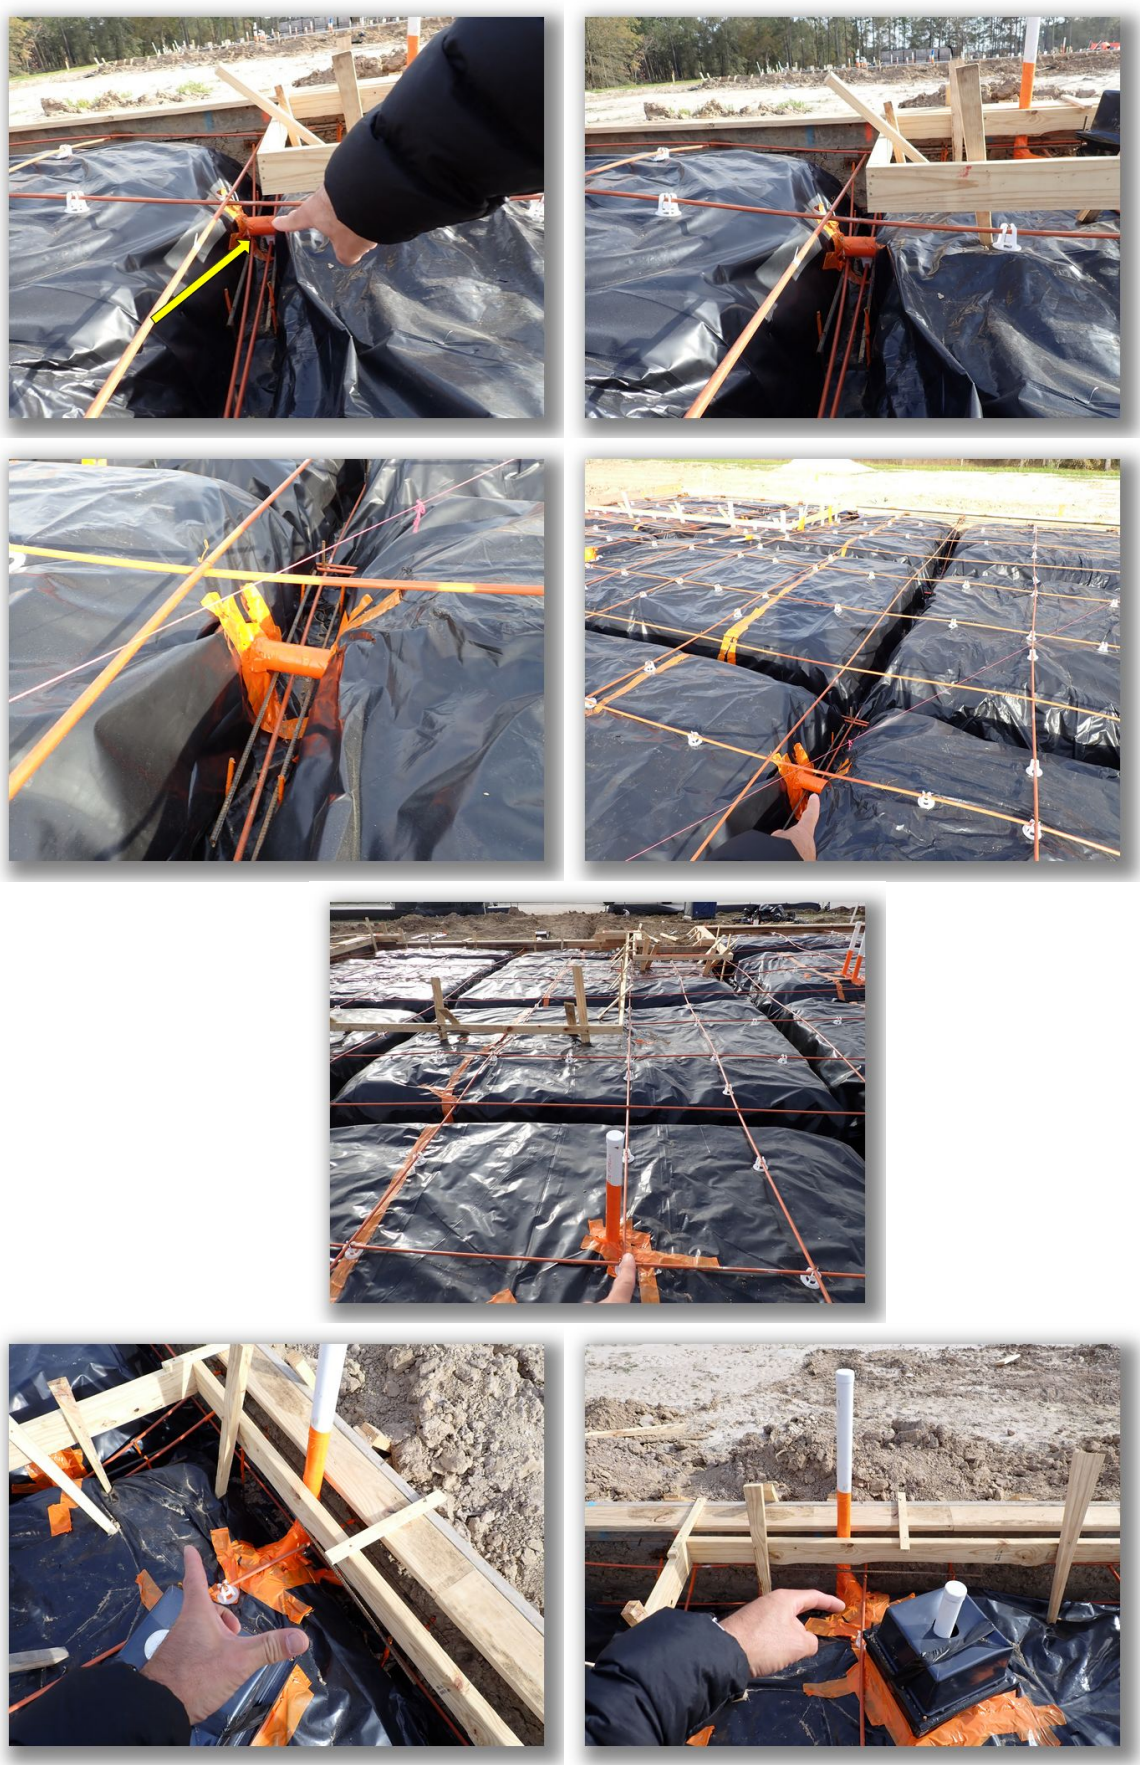
- The post tension tendon should have a minimum of 3-inches of clearance from waste pipes through the beams footings. The tendon has poor clearance in the primary bathroom. A support chair can be placed between the pipe and the tendon tied in place to correct this condition.

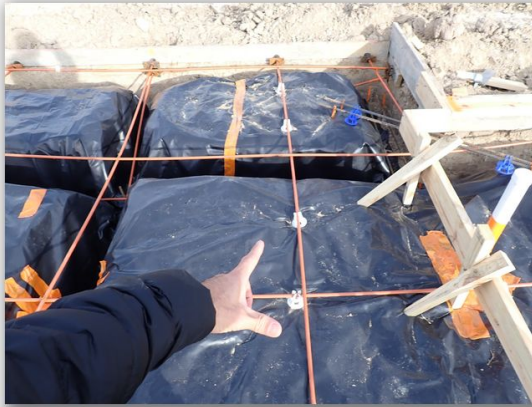
- The reinforcement intersections are not properly secured (tied) together. All reinforcement intersections should be further evaluated and properly secured together prior to pouring concrete.

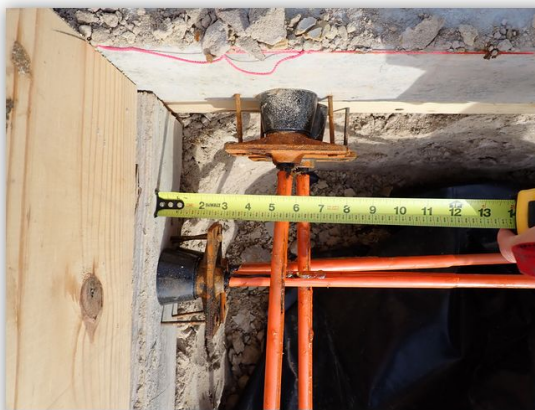
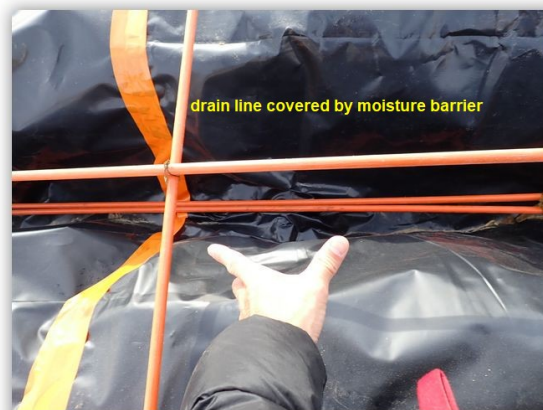
- The post tension anchors are installed within 6-inches of the form corners on the north side of the foundation. The anchors should be moved a minimum of 6-inches away from the corners to help prevent blowouts from occurring when tension is applied to the tendons.

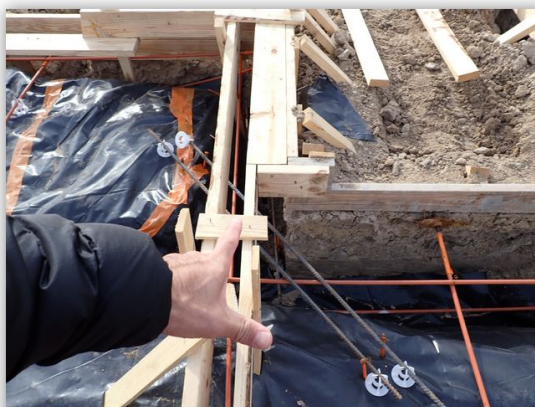
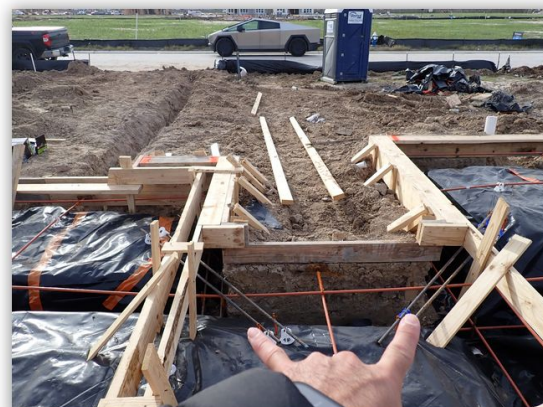
- The rebar is touching the post tension cable on the south side side of the foundation. This condition should be corrected prior to concrete pour.

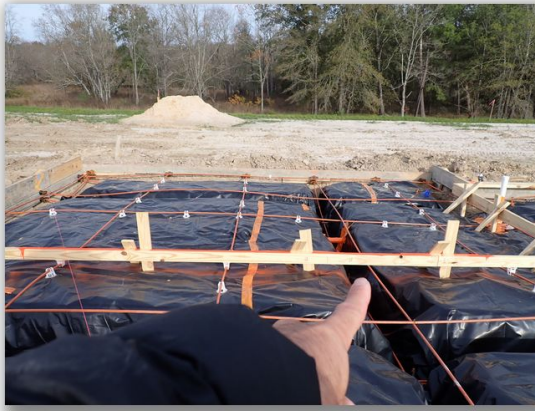
- One of the post tension cables was observed to be touching the form board for the back porch at the time of inspection. The cable should be separated with a chair.

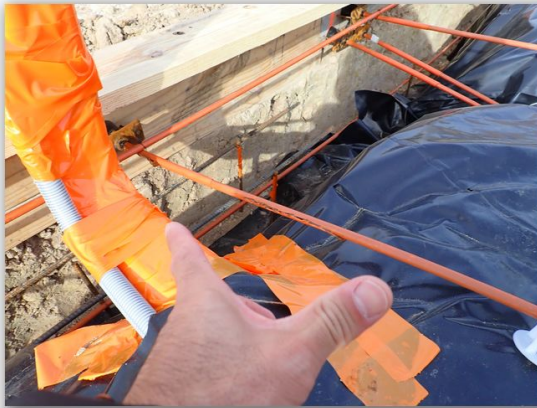
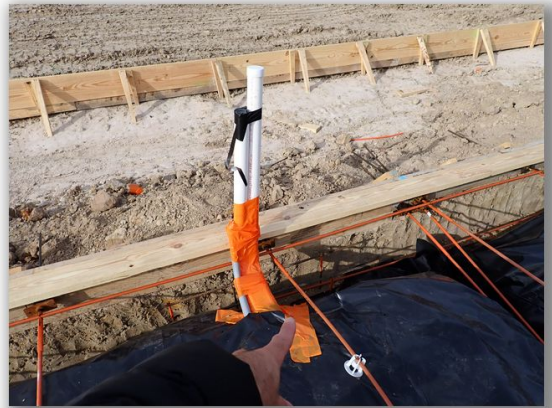
- There is damaged sheathing on the post tension cables in the kitchen. This should be corrected to help prevent concrete from adhering to the metal post tension cable.

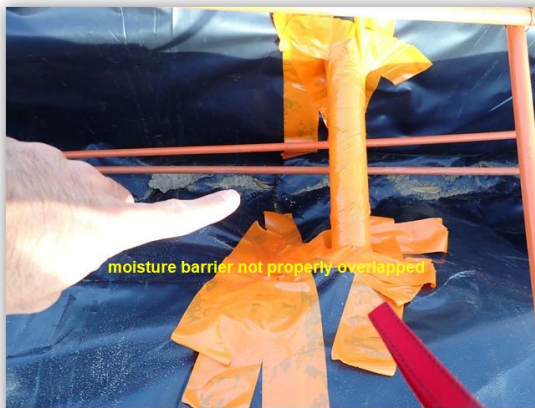
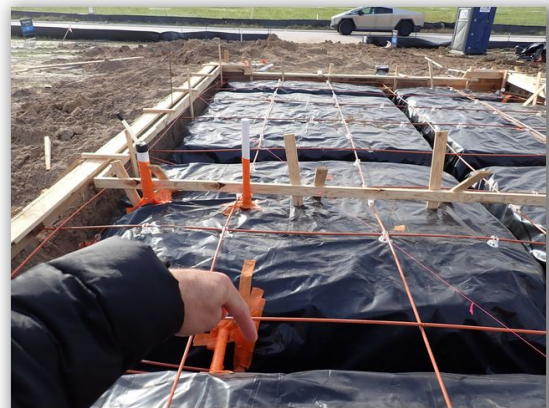
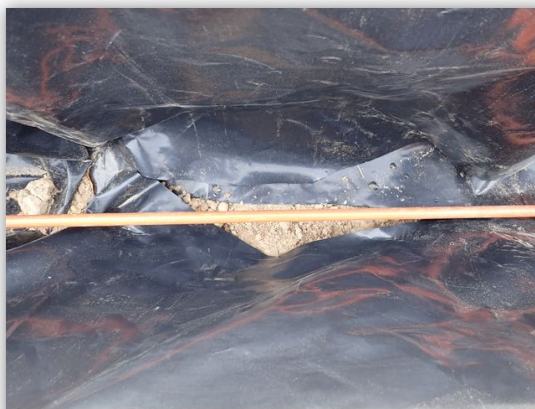
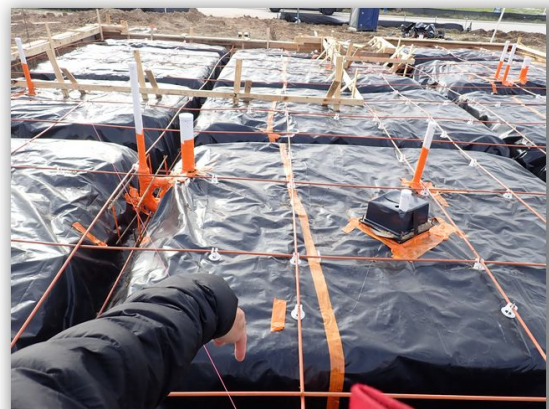
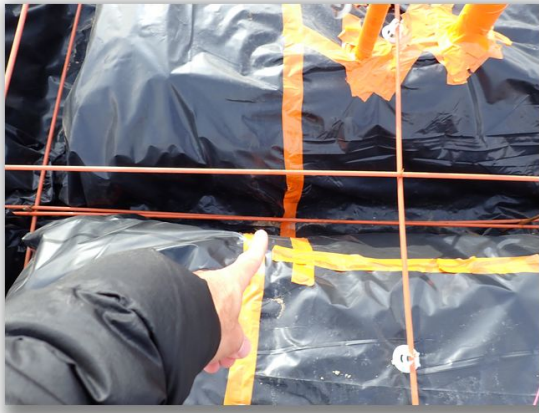
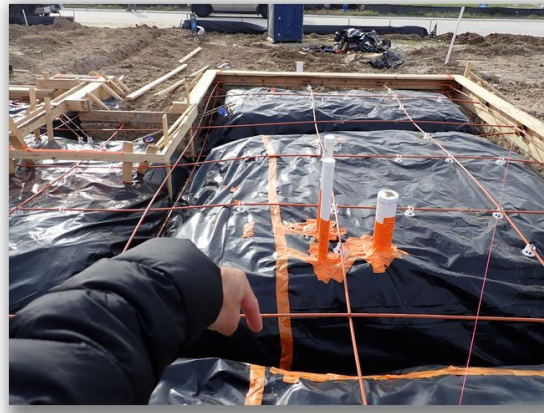
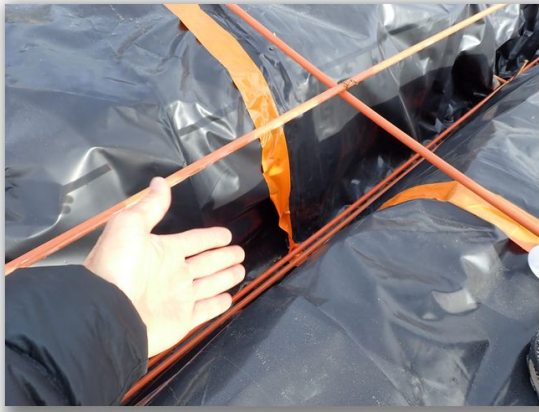
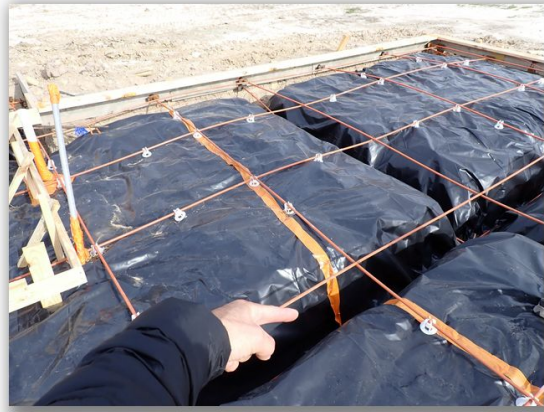
- The moisture/vapor barrier is not properly overlapped in the hall bathroom; guest bedroom; laundry room; primary bedroom. The moisture/vapor barrier should be overlapped a minimum of 6-inches to provide a continuous sheet under the entire foundation and any joints taped to ensure that there is no separation when concrete is placed.

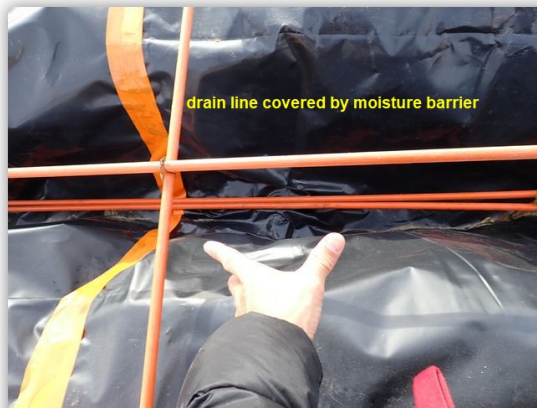
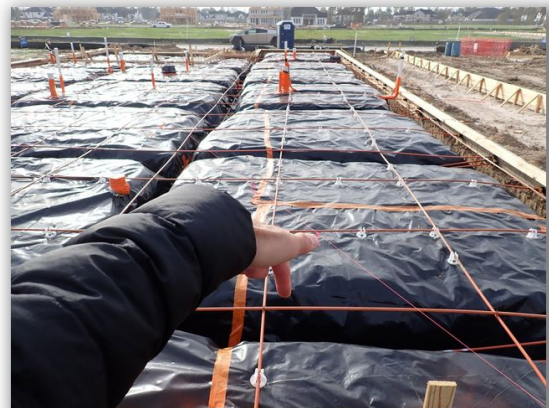
- One of the drain lines in the living room area was observed to be covered by the vapor barrier at the time of inspection. This condition should be further evaluated.

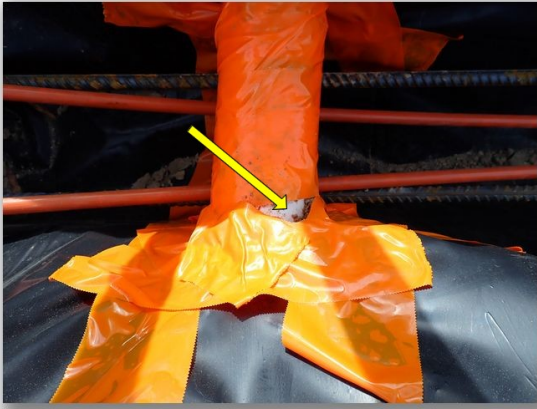
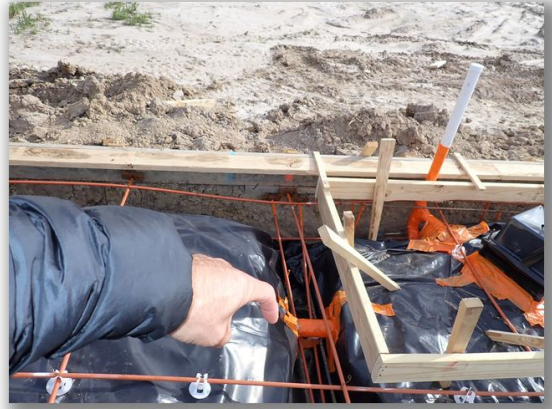
- The water supply lines should be properly protected in the beam / footing areas. The water line is not properly protected across the beam / footing in the primary bathroom. This condition should be corrected prior to the concrete being poured to help prevent future slab leaks from occurring.
