**Sample Report  
1234 Sample Report  
Fulshear, TX 77441**

**December 19, 2025**

## PROPERTY CONDITION REPORT

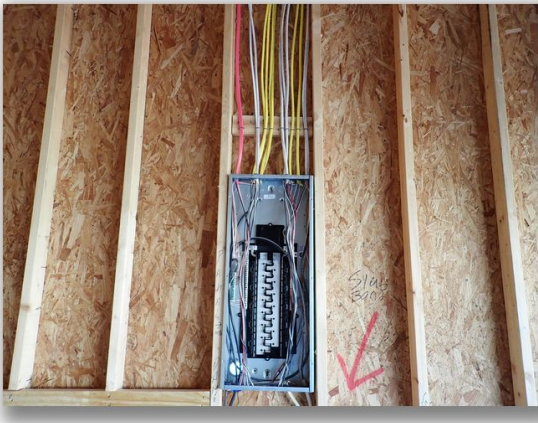
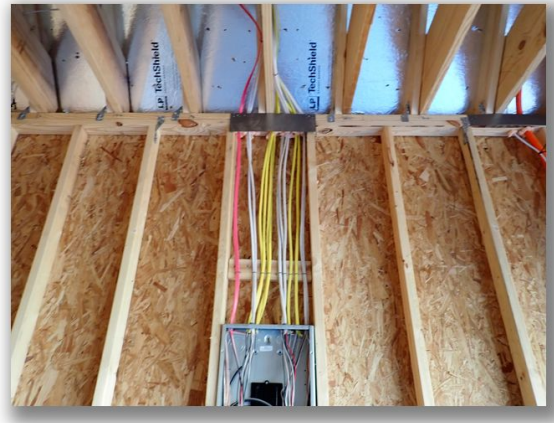
- Nail plates are needed to help protect the electrical branch circuit wiring from fastener (nail or screw) damage in the garage, front corner bedroom.
- The junction box in the hall bathroom is twisted/not level. It is recommended to straighten the junction box prior to sheetrock installation.
- One of the junction boxes in the kitchen was observed to be damaged at the time of inspection.
